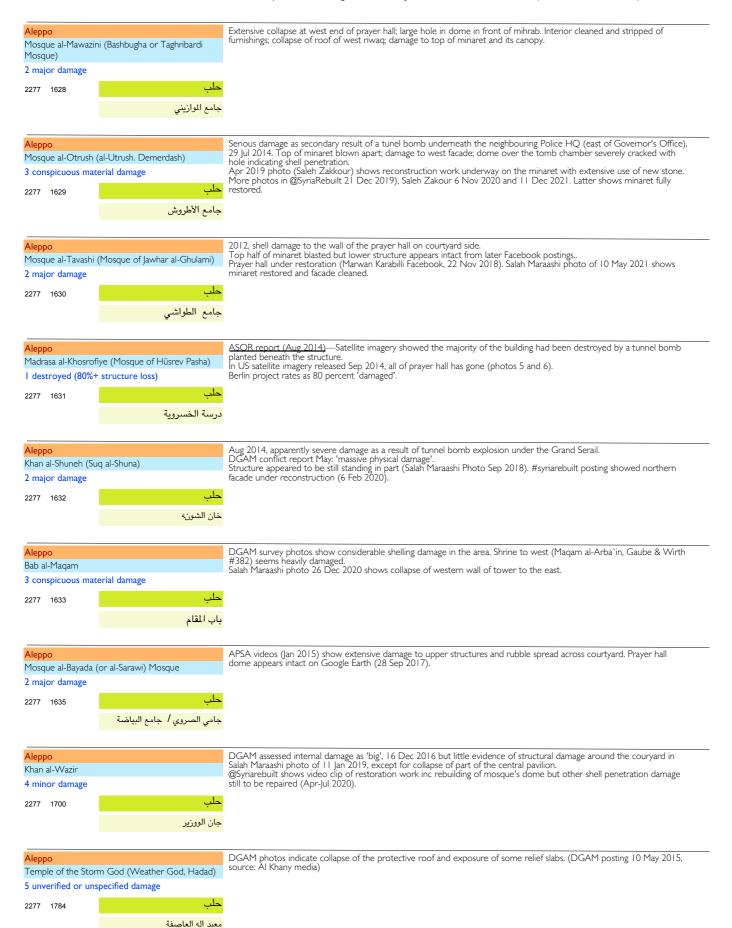
APSA Mar 2015 posted many photos. showing severe damage to the minaret.

Interior appeared intact in Salah Maraashi photo 22 Jun 2019 but signs of collapsed rubble (possibly from minaret) outside east door now partly covered by opportunistic cement roof.

@SyriaRebuilt 27 Dec 2019 reports on reconstruction work including minaret.

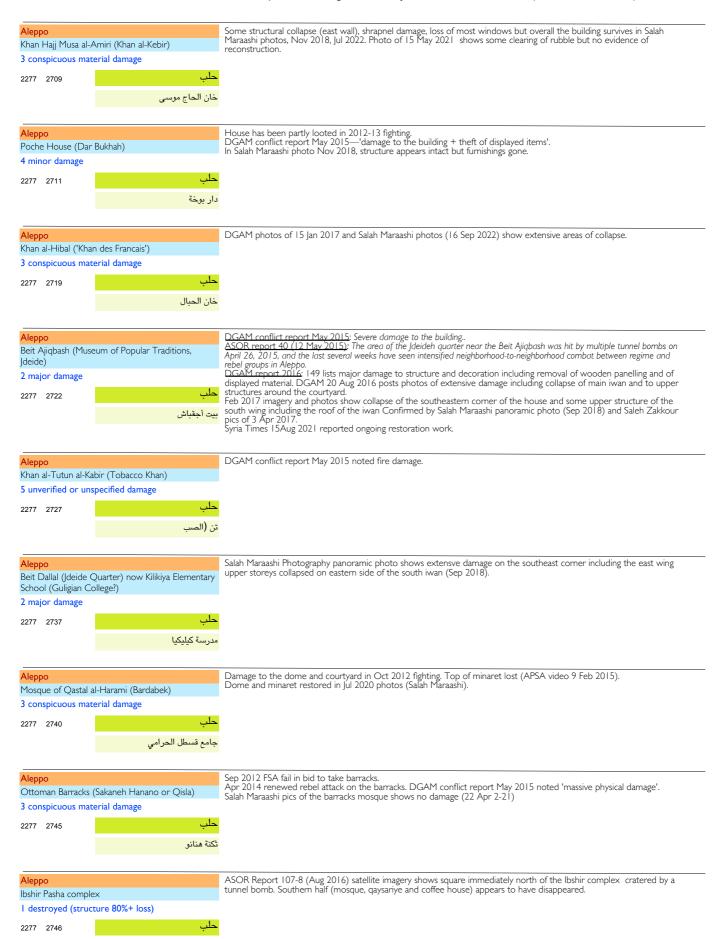
جامع الميداني

Many sections of the suq and other medieval buildings in the ancient city were destroyed, ruined or burnt as a result of fighting between the Free Syrian Army and the Syrian Armed Forces beginning on 25 September 2012. (Wikipedia) UNOSAT/UNITAR (Dec 2014)—Of the 20 sougs which sustained damages, 4 sougs sustained a minimum of moderate damage (and at least one is suspected to have severe damage inside); 19 sustained severe damage; and 11 have been completely destroyed. Aleppo Suq al-Atarin 2 major damage DGAM photos 21 Jan 2017 showed extensive area of collapse and incineration. 2277 2682 سوق العطارين Salah al-Maarashi photo (May 2016) shows dome of prayer hall collapsed and structure west of courtyard largely missing. Minaret still standing on precarious base. 3-storey building on Great Mosque St collapsed and rubble removed. New entrance to mosque added on SW corner. Hajj Musa al-Amiri Mosque (Mosque al-Khayr) Repair work underway in Salah Maraashi photo 7 Jan 2020. 3 conspicuous material damage 2277 2683 جامع الحاج موسى *ل*جامع الخير 'Damage to the building' noted in DGAM May 2015 conflict list. Some signs of minor structural damage (eg broken windows and charring) in Salah Maraashi photo 16 May 2020 Tekkiye or Mosque of Aslan Dada 4 minor damage 2277 2684 خامع اصلان دادا DGAM conflict report May 2015—'damage to the building'. DGAM assessed internal damage as 'big', 16 Dec 2016. Salah Maraashi photo (2 Dec 2018) shows extensive internal damage to upper structures but lower walls seem intact. Khan al-Harir (Silk Khan) Salah Maraashi photo (2 Dec 2018) shows extensive internal damage to upper structures but lower walls seem intact. Windows and doors missing. Salah Maraashi shot of Suq al-Majidiya shows reconstruction work on decorative frieze around the entrance arch (4 Jan 2020). Syria Times 18 Dec 2019 reports on rehabilitation work including to entrance doorway carried out by Aleppo City council with funds from AKTC. Salah Maraashi photo (18 Nov 2020) shows suq to east of khan restored and entrance gateway 2 major damage 2277 2685 خان الحرير cleaned. Salah Maraashi photo 28 Jul 2022 shows large areas of roof still missing Aleppo DGAM photos 9 Feb 2017 shows rubble strewn across courtyard. Pockmarking from shell shrapnel. Salah Maraashi photo 7 Jun 2019 showed one section damaged by shelling. Khan al-'Ulabiye 3 conspicuous material damage حلب 2277 2688 جان العلبية Appears undamaged in Salah Maraashi panoramic photo but some holes in courtyard awning Sep 2018. Aleppo Berlin project damage assessment (2019), however, notes that all 12 graves in the courtyard were vandalised and removed by the radical group controlling the area until 2015. Zawiya (or Tekkiye) al-Hilaliye 3 conspicuous material damage 2277 2690 الزاوية الهلالية APSA reported mosque damaged during attack by 'Russian aircraft' 26 Sep 2016. Dome and at least two sides of courtyard destroyed and eastern outer wall. Minaret survived Mosque al-Tawba (al-Tuba) 2 major damage 2277 2693 جامع التوبة Signs of severe structural collapse around courtyard in video posted by Marwan Karabilli (Apr 2019). Signs of upper structure collapse in Salah Maraashi pic 17 Jan 2022. No indication of restoration. Mosque Sheikh Hamud (ibn al-'Ajami, Ahmad al-3 conspicuous material damage 2277 2698 خامع شيخ حمود APSA photo posted Jul 2014 shows damage which appears to date from 2011. 'Massive physical damage' on DGAM May 2015 conflict list. 16 Oct 2016, AMC clip shows further major damage including loss of most of the minaret. Salah Maraashi photo (29 Feb 2020) shows collapse of 50%+ of prayer hall structure. Aleppo Mosque al-Maidani (Maydani or Midani) 2 major damage 2277 2702

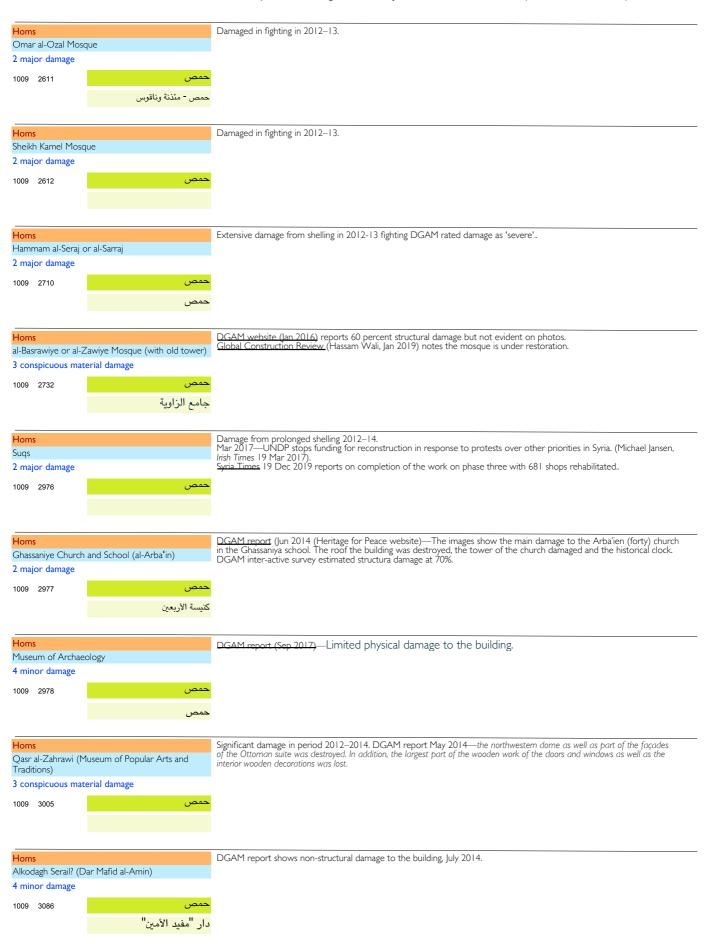
جامع كعب الأحبار

Minaret shown as seriously damaged by shelling in APSA report dated Mar 2014. More than half the structure had been Homs lost. DGAM report (Sep 2017)—Severe damage to the building, including %80 structural damage and %90 interior damage al-Fada'l Mosque (Mosque of Virtues) 2 major damage (furnishing and decoration) 1009 1695 حمص - مسجد الفضائل DGAM report June 2014—Most affected was the Dalati Mosque or Mosque of Sultan Abdul Hamid, also known as the Mosque of Adaakk. This Mosque is considered one of the most important Islamic monuments and archaeological sites in Alhamidiyah Street in Homs. According to the report of the Technical Committee, the bulk of the minaret of the mosque has been destroyed. Bombs tamished its southern and south-eastern interfaces, and shattered a large section of windows Dalati Mosque (Mosque of Sultan Abdul Hamid) 2 major damage and wooden doors, as well as shops belonging to the mosque. They also demolished the southern part of the mosque and a large part of the roof. 1009 1697 and a large part of the root. DGAM conflict report May 2015—Damage to the building, including %60 structural damage and 50% interior damage Wali in Global Construction Review (Jan 2019) has photo of the restoration of the mosque (photo 9). جامع الدالاتي Extensively damaged in fighting in 2012–13. DGAM conflict report May 2015—Severe of Homs –Severe damage to the building, including %40 structural damage and %80 interior damage Mosque of Khalid ibn al-Walid (fumishing and decoration). 2 major damage Under restoration 2016. trish Times reported mosque under restoration Apr 2019. Youtube video (2019) reports that the mosque fully reconstructed 1009 1702 including the minarets. سجد خالد بن الوليد The orthodox church.info website reports (21 May 2014) that the paintings and iconostasis were being restored after damage done by rebels before their May 2014 evacuation of the city. DGAM reported 20 percent structural damage to the building (Sep 2017). Homs Church of St Elian 3 conspicuous material damage 1009 1757 كنيسة مار إليان Damaged in fighting in 2012–13. May 2014 DGAM photos show minaret still standing. Mosque of Mustafa Pasha al-Husseini 2 major damage 1009 2605 دحية الكلي Assessed by DGAM as 'seriously danaged' (Corner of the minaret blasted off.) al-Humairi Mosque (al-Kelaa Mosque) 3 conspicuous material damage 1009 2606 مسجد ذي الكلاع أ الكنيسة الإنجيلية Minaret partly destroyed in fighting in 2012–13. <u>DGAM conflict report May 2015</u>—Destruction of the minaret + 80% structural damage and 70% interior damage (furnishing and decoration). Subsequent DGAM photos show only the lowest 5 m of the minaret remaining; prayer hall standing but burnt Homs Abu Dhar al-Ghafari (or- al-Asiati?) Mosque 2 major damag 1009 2607 أبي ذر العصياتي Minaret damaged in fighting in 2012-13. Homs al-Sheikh Nasr Mosque 2 major damage 1009 2608 الشيخ ناص Homs Dome partly destroyed in fighting in 2012–13. Wahshi Wethoban Mosque 2 major damage 1009 2609 Minaret largely destroyed in fighting in 2012–13. DGAM conflict report May 2015: 'Severe damage to the building, including %90 structural damage and %90 interior Ka'ab al-Ahbar Mosque damage (furnishing and decoration). 2 major damage
