# FIVE YEARS OF CONFLICT

The State of Cultural  
Heritage in the  
Ancient City of Aleppo

A comprehensive multi-temporal satellite  
imagery-based damage analysis for the  
Ancient City of Aleppo

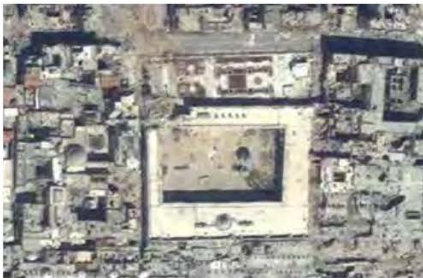
The Great Mosque's magnificent minaret built in 1090 during the rule of the local Seljuq dynasty (1080–1117) testified to the artistic quality and high skill of the local stonemasons. The minaret was destroyed on 24 April 2013.

**Figure 3. Great Mosque of Aleppo.** 23 September 2013 © 2013 DigitalGlobe (Source: U.S. Department of State, NextView License).

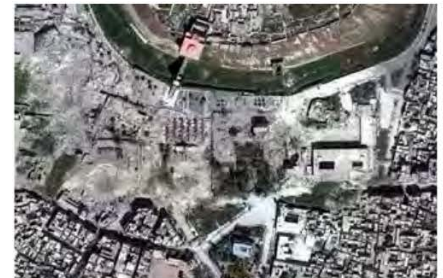
Between 2014 and 2015, most of the historic buildings south of the Citadel of Aleppo were destroyed or severely damaged, including the New Serail, Madrasa al-Sultaniyya, Hammam Yalbougha al-Nasiri and al-Khusrawiyya Complex.

**Figure 5. Historic Buildings - South of the Citadel of Aleppo.** 26 April 2015 © Pléiades Image CNES 2015, Distribution Airbus Defence and Space.

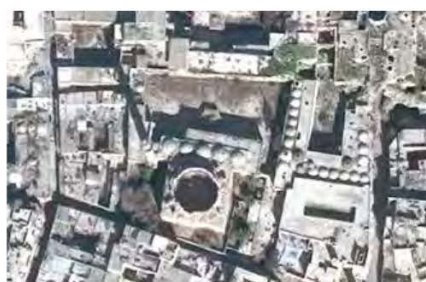
**Figure 7. Al-Adiliyya Mosque.** 20 February 2017 © 2017 DigitalGlobe (Source: U.S. Department of State, NextView License).

Al-Adiliyya Mosque is an important example of Mimar Sinan's provincial mosques. On 17 February 2017, al-Adiliyya Mosque was severely damaged.

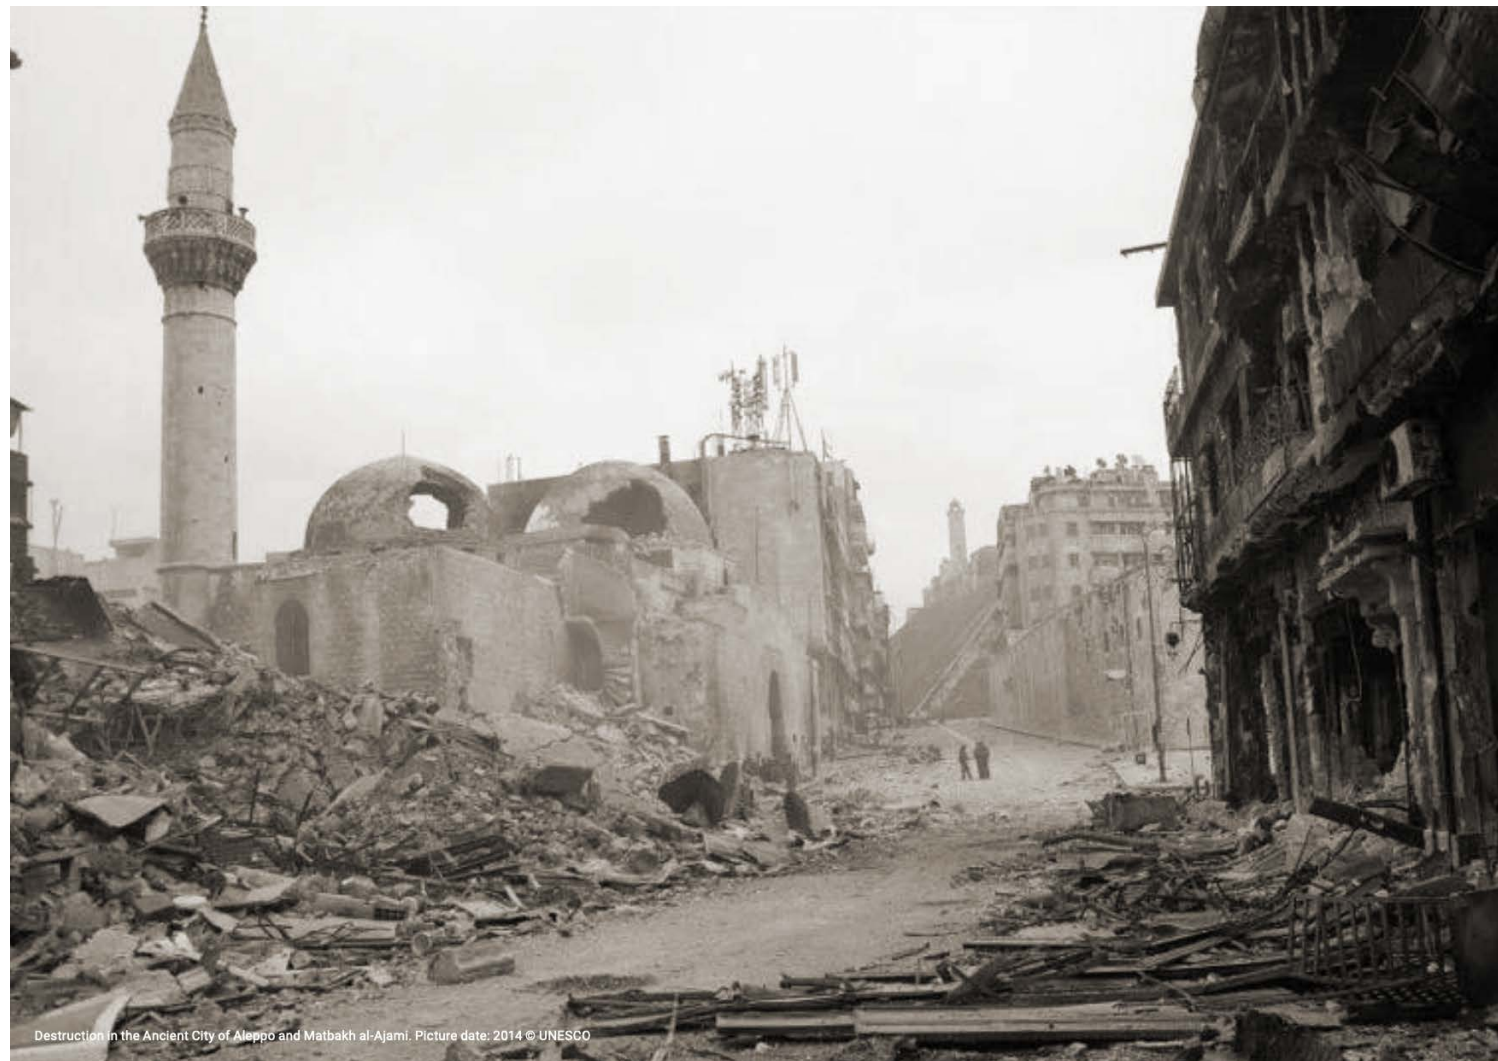
Destruction in the Ancient City of Aleppo and Matbakh al-Ajami. Picture date: 2014 © UNESCO

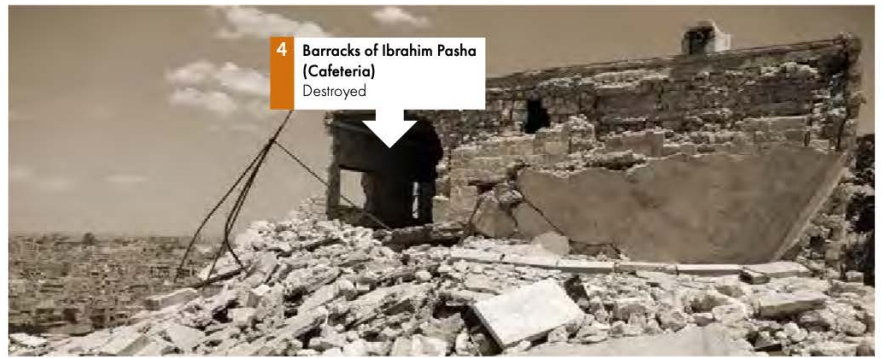
**Barracks of Ibrahim Pasha (Cafeteria section).** Picture taken from the west side of the Ibrahim Pasha Barracks looking into the western end section of the building that was completely destroyed. Picture date: 28 May 2017 © Art Graphique & Patrimoine.

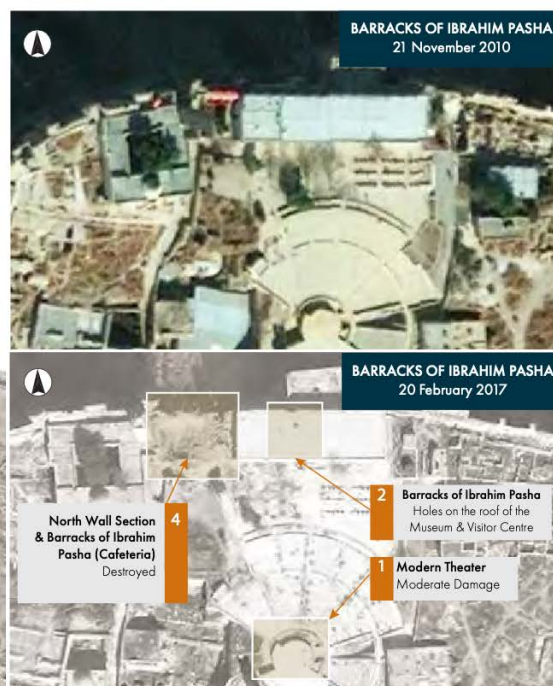
One of the towers and a section of the North Wall between the Great Mosque and the Barracks of Ibrahim Pasha have sustained severe damage (Damage Point 4). Damage was identified for the first time using imagery collected on 18 September 2016 when compared with imagery collected on 23 September 2013 (see Figures 15 and 16).

**Figures 11 and 12. Barracks of Ibrahim Pasha.** *Top right (Before image):* 21 November 2010 © 2010 DigitalGlobe (Source: U.S. Department of State, NextView License). *Bottom right (After image):* 20 February 2017 © 2017 DigitalGlobe (Source: U.S. Department of State, NextView License).

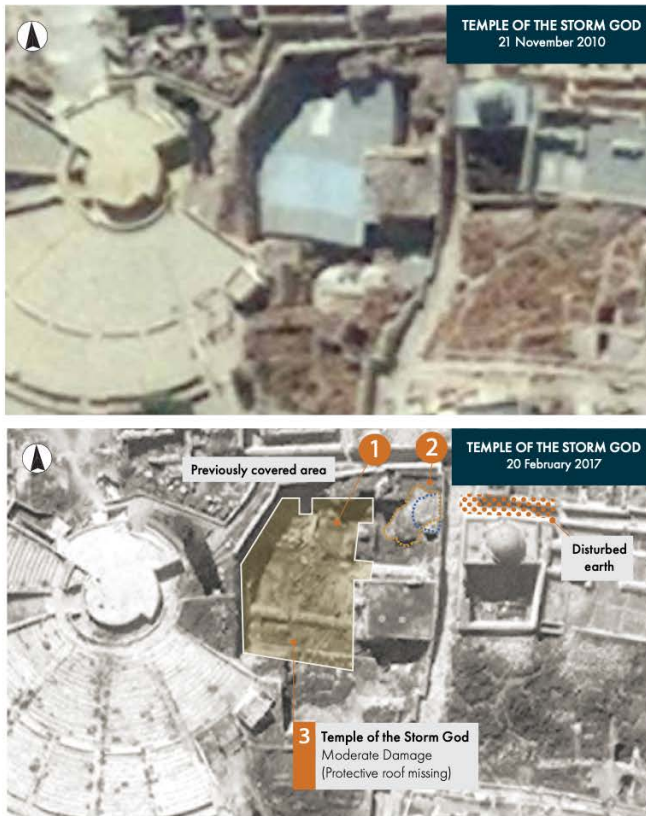
A roof was constructed in 2005 to protect the excavated area of the Temple of the Storm God. This had collapsed by May 2014. By 2016 the collapsed roof had been entirely removed (Damage Point 3). The appearance of the excavation under the roof is unknown. Between 2016 and 2017, an unknown number of sandbags burst and the content was spread over a larger area (blue limits – extent of disturbed earth in 2013, and orange limits – extent of disturbed earth in 2017. See Figures 13 and 14). The sand bags were placed to protect the site and to stabilize the walls of the excavation.

**Figures 13 and 14. Temple of the Storm God.** *Top left (Before image):* 21 November 2010 © 2010 DigitalGlobe (Source: U.S. Department of State, NextView License). *Bottom left (After image):* 20 February 2017 © 2017 DigitalGlobe (Source: U.S. Department of State, NextView License).

In 2017, the area with the disturbed earth (see Damage Point 2) is significantly larger in width and height, a possible indicator that the protective sand bags located in that corner burst with the contents spread over a larger area.

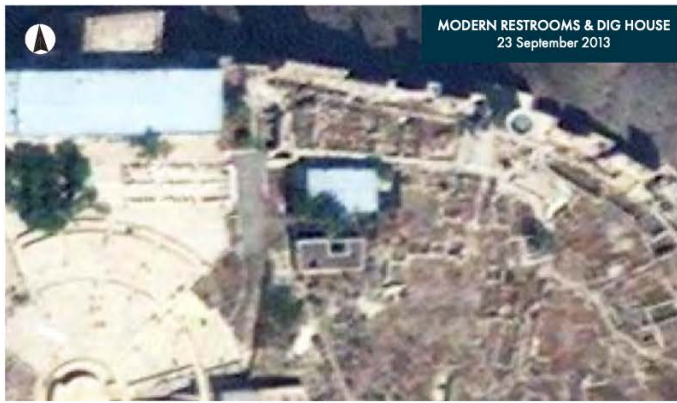
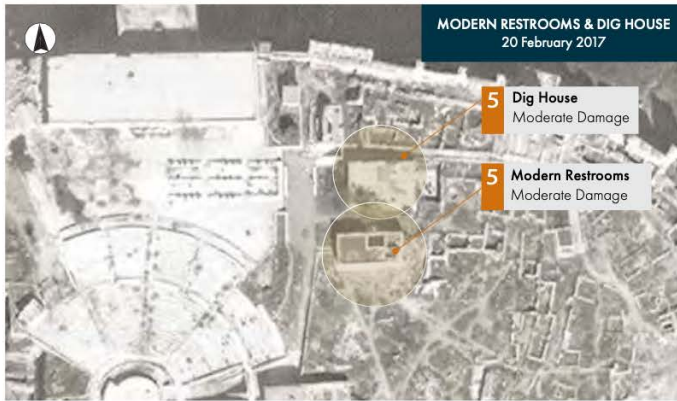
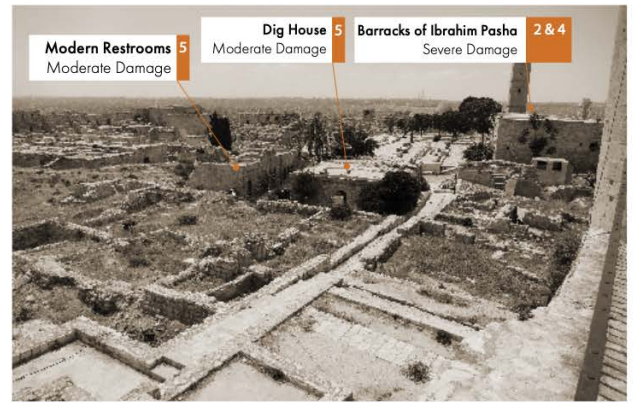
The modern restrooms have partially collapsed in the southeast corner (Damage Point 5), and there are several holes in the roof. The opposite building, which was used as a dig house by the Syrian-German excavation team, also sustained moderate damage with two holes in the roof and a possible collapse at the northwestern end (see Figures 20 and 21, Damage Point 5).

**Figures 20 and 21. Modern Restrooms and Dig House.** *Top left: (Before image):* 23 September 2013 © 2013 DigitalGlobe (Source: U.S. Department of State, NextView License). *Bottom left (After image):* 20 February 2017 © 2017 DigitalGlobe (Source: U.S. Department of State, NextView License).

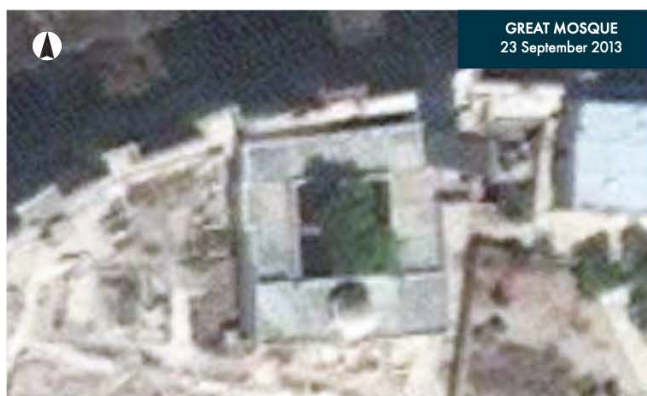
A debris pile indicates damage to the eastern wall and base of the minaret of the Great Mosque (Damage Point 20). Additional debris is clearly visible around the North and East Wall of the Great Mosque with some possible damage to a small section of the North Wall/roof (Damage Point 4), though the rest of the structure appears undamaged (see Figures 24 and 25).

Figure 24. Great Mosque. 23 September 2013 © 2013 DigitalGlobe (Source: U.S. Department of State, NextView License).

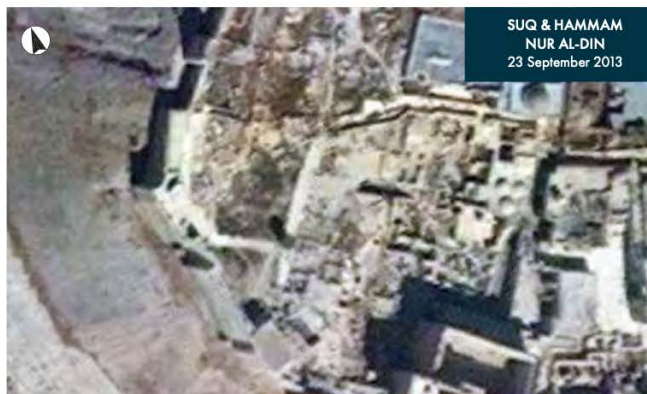
By 2016 one of the buildings in the excavation area around the suq had been damaged and there is at least one hole, possibly two, due to subsidence or the gradual sinking of a small arch in the archaeological area (Damage Point 22). The buildings around the Hammam Nur al-Din have also been damaged (see Figures 26 and 27).

Figure 26. Hammam Nur al-Din. 23 September 2013 © 2013 DigitalGlobe (Source: U.S. Department of State, NextView License).

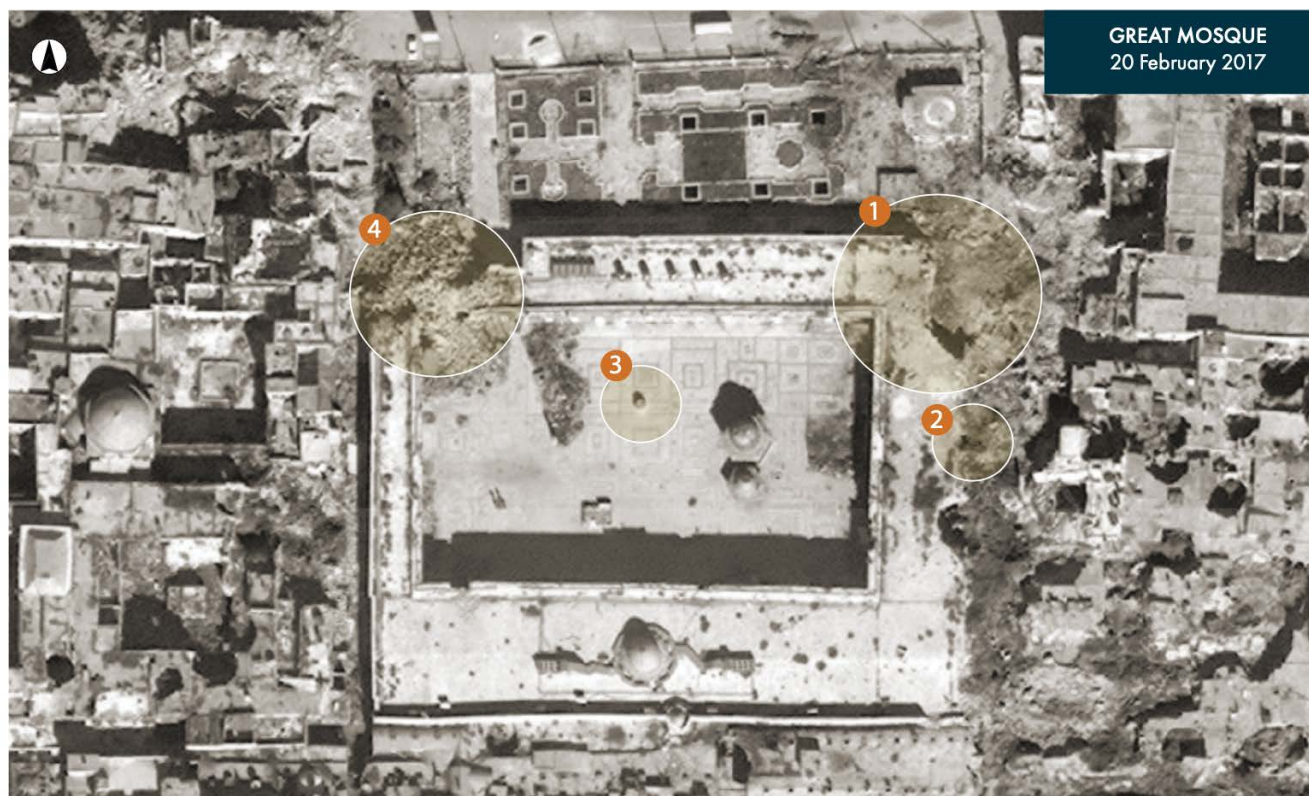
The minaret was destroyed during fighting in April 2013 (see Figure 31, Damage Point 4). In September 2012, a huge fire in the covered suqs damaged much of the eastern side of the mosque (the outer wall abutting the suqs and the eastern portico) and destroyed the library. This severe damage was visible by 2014 on satellite imagery in the eastern portico (see Figure 31, Damage Point 2). In addition, the stone-tiled courtyard is partially destroyed. Lastly, the garden to the north has suffered moderate damage. The entrance passage to the suq from the eastern portico (see Figure 31, Damage Point 1) has been seriously damaged. The imagery of 2015 and 2017 show additional damage to the eastern portico. A section of the eastern wall and the northeastern corner of the mosque are destroyed. The images also show the protective work undertaken on the sundial in 2013 (see Figure 31, Damage Point 3), which was wrapped with sandbags and encased in cement to protect it. Smoke blackening is visible on the satellite imagery, affecting at least one of the galleries, and DGAM confirmed that fire also destroyed al-Waqifiyya Library.

Figure 31. Great Mosque of Aleppo. 20 February 2017 © 2017 DigitalGlobe (Source: U.S. Department of State, NextView License).

- 1 Entrance passage to the suq from the eastern gallery portico
- 2 Eastern portico
- 3 Protective work undertaken on the sundial in 2013
- 4 Great Mosque Minaret destroyed in April 2013

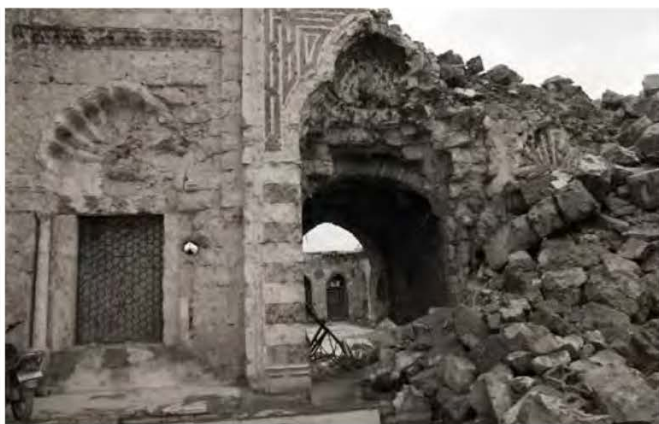
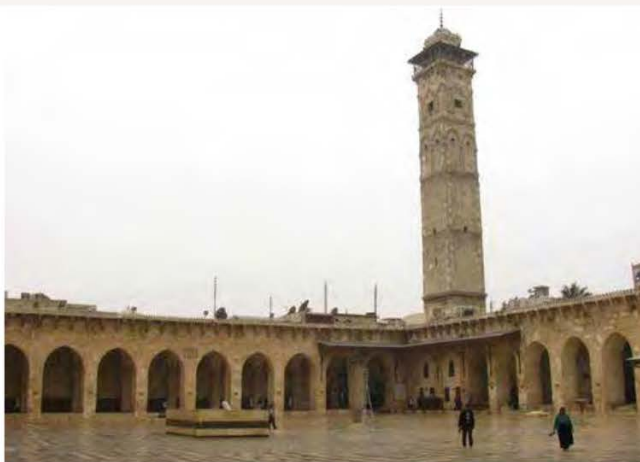
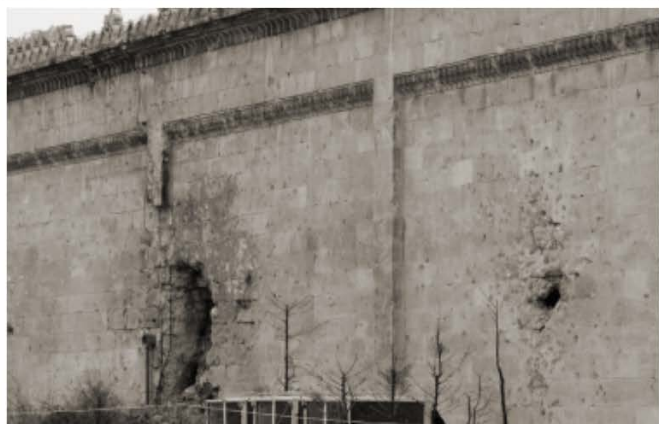
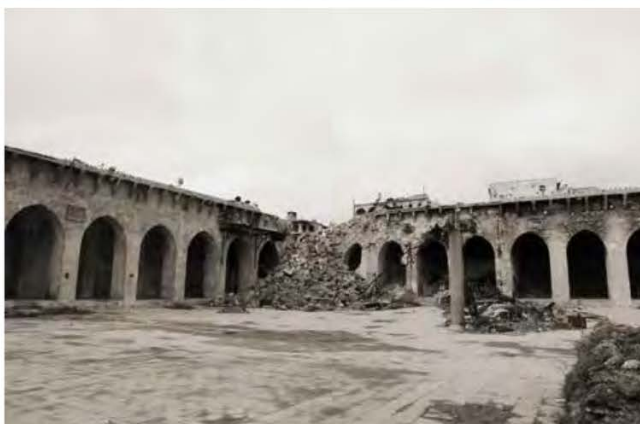
**Great Mosque of Aleppo.** *Top left:* Damage to the Great Mosque's northern entrance. Picture date: 16 January 2017 © UNESCO/G. Khawam. *Bottom left:* Damage to the Great Mosque's northern façade. Picture date: 16 January 2017 © UNESCO/G. Khawam. *Top right:* The Great Mosque of Aleppo, the Minaret. Picture date: 28 December 2009 © Alain Hornsi\*. *Bottom right:* Great Mosque of Aleppo and the destroyed minaret. Picture date: 16 January 2017 © UNESCO/G. Khawam.

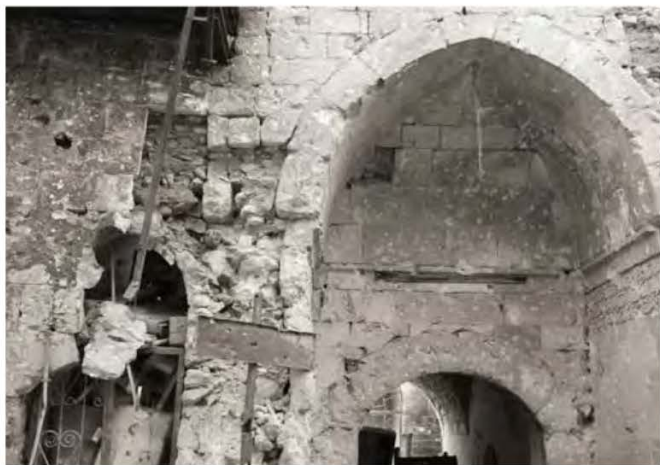
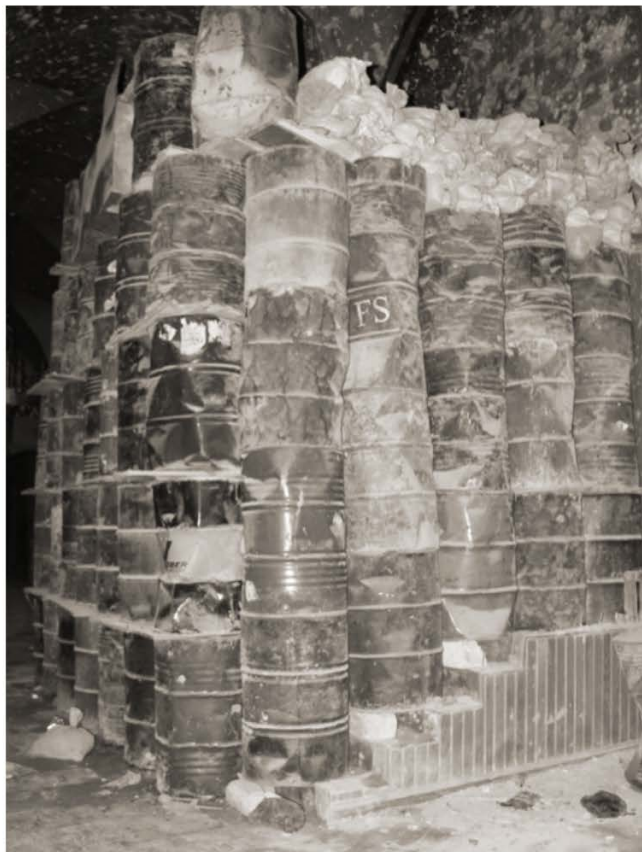
**Great Mosque of Aleppo.** *Top left:* Damage to the Great Mosque's western entrance. Picture date: 16 January 2017 © UNESCO/G. Khawam. *Bottom left:* Damaged pillar in the Great Mosque's main prayer hall. Picture date: 16 January 2017 © UNESCO/G. Khawam. *Bottom right:* One of the mihrabs in the prayer hall of the Great Mosque. Picture date: 16 January 2017 © UNESCO/G. Khawam. *Right:* Protective barrels in the prayer hall of the Great Mosque. Picture date: 16 January 2017 © UNESCO/G. Khawam.

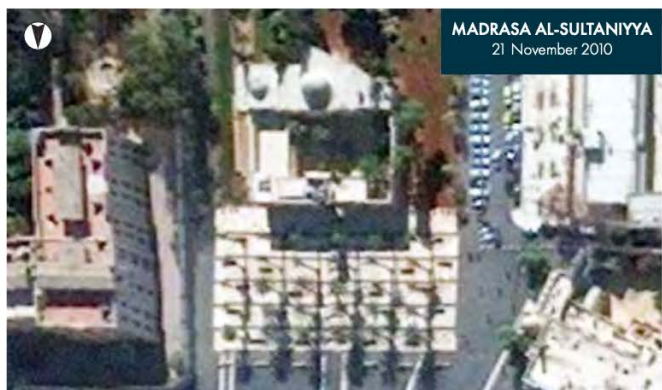
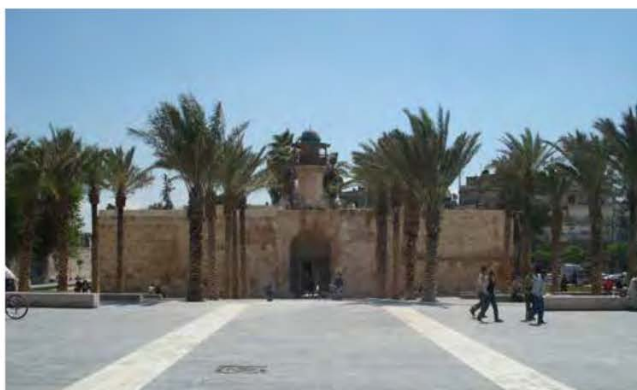
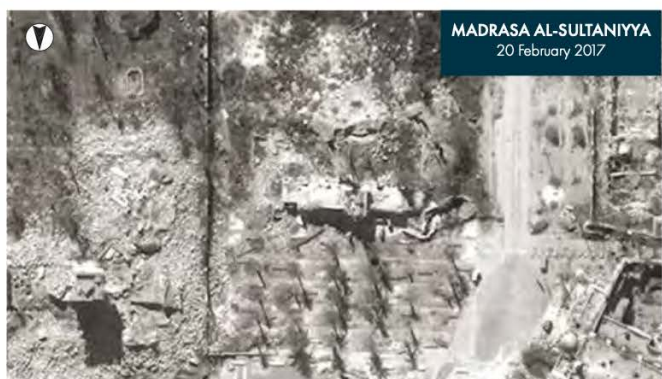
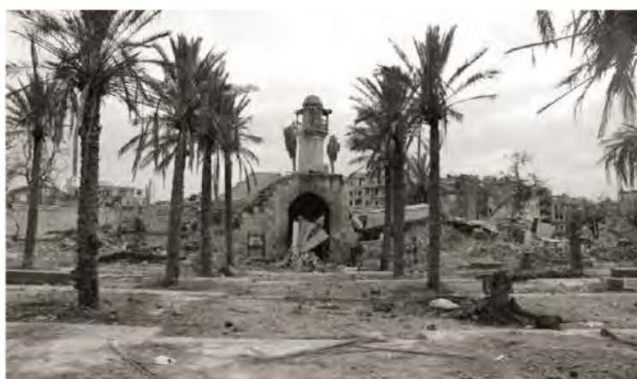
Among the Ayyubid madrasas established in Aleppo, Madrasa al-Sultaniyya was of particular historic importance as it contained the mausoleum of al-Zahir Ghazi, the famous ruler of Aleppo. Architecturally, it was rich in inscriptions and contained splendid architectural features representing the Ayyubid style, such as the mihrab in the prayer hall and the pool in the courtyard. Consequently, the overall historical loss is categorized as critical.

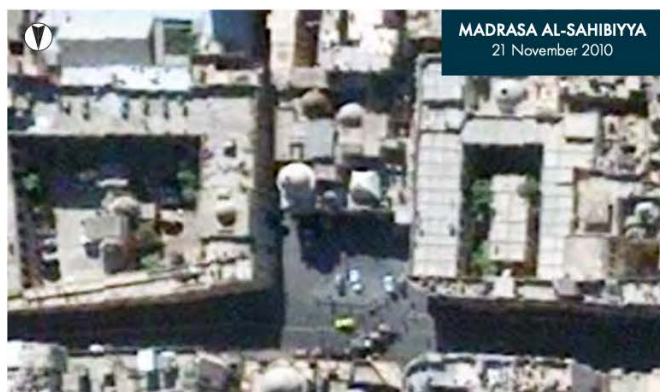
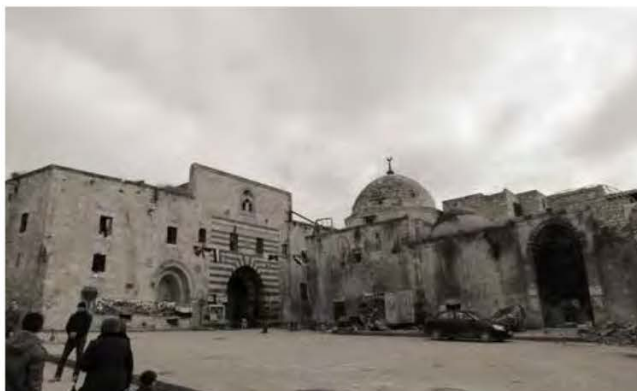
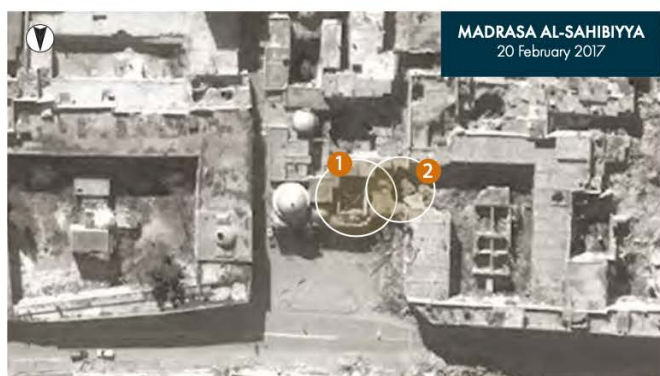
**Figures 34 and 35. Madrasa al-Sahibiyya.** *Top left (before image):* 21 November 2010 © 2010 DigitalGlobe (Source: U.S. Department of State, NextView License). *Bottom left (after image):* 20 February 2017 © 2017 DigitalGlobe (Source: U.S. Department of State, NextView License). *Ground pictures. Top right:* Khan al-Wazir and Madrasa al-Sahibiyya. Picture date: 16 January 2017 © 2017 UNESCO/C. Menegazzi. *Bottom right:* Madrasa al-Sahibiyya, the collapsed kuttab. Picture date: 16 January 2017 © 2017 UNESCO/C. Menegazzi.

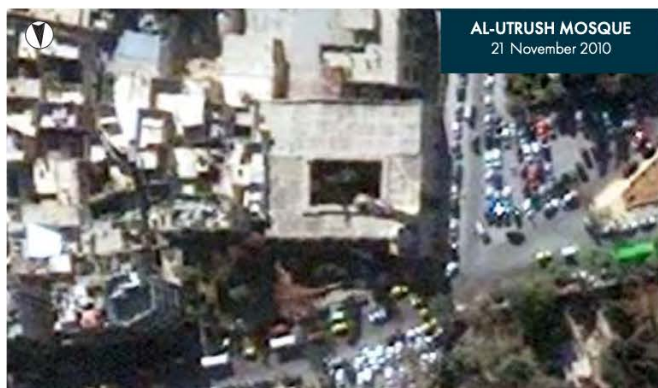
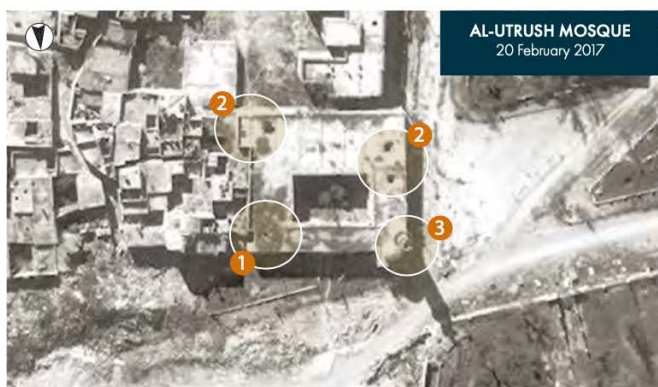
**Figures 36 and 37. Al-Utrush Mosque.** *Top left (Before image):* 21 November 2010 © 2010 DigitalGlobe (Source: U.S. Department of State, NextView License). *Bottom left (After image):* 20 February 2017 © 2017 DigitalGlobe (Source: U.S. Department of State, NextView License). *Ground picture. Right:* Al-Utrush Mosque. Picture date: 16 January 2017 © 2017 UNESCO/C. Menegazzi.

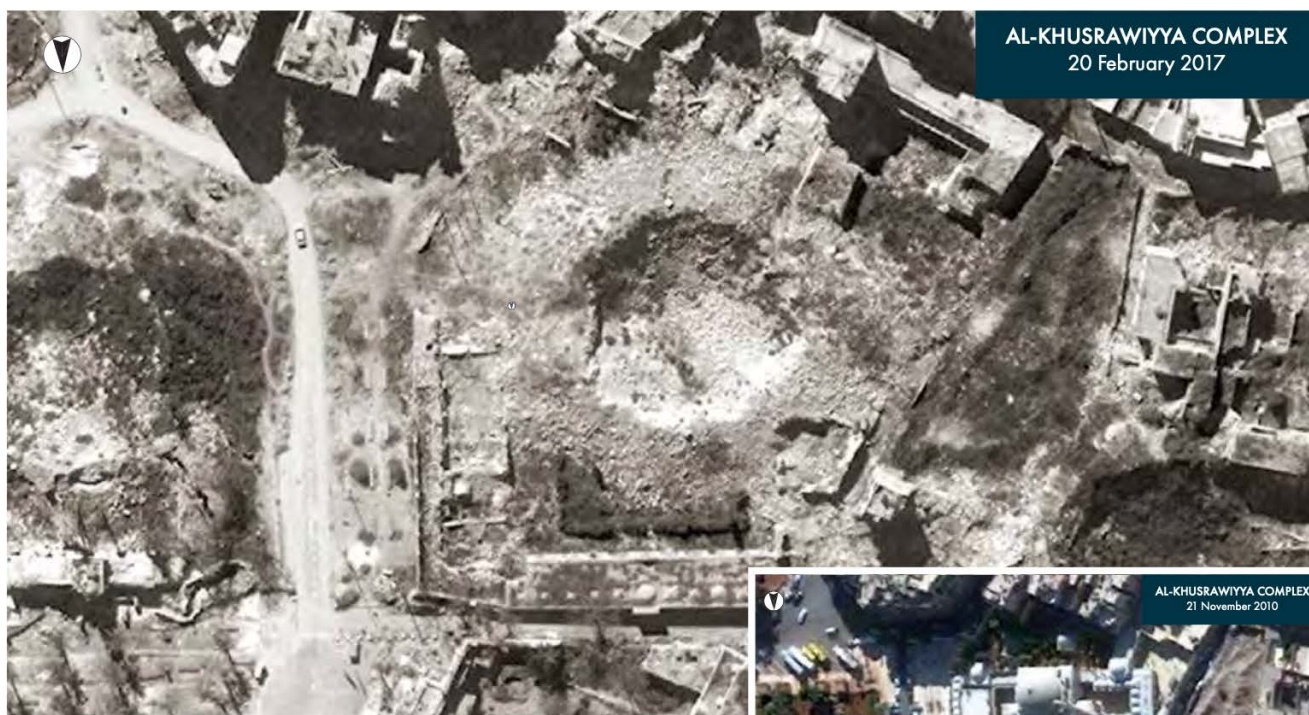
**Figures 38 and 39. Al-Khusrawiyya Complex. Bottom right (Before image):** 21 November 2010 © 2010 DigitalGlobe (Source: U.S. Department of State, NextView License). **Full page (After image):** 20 February 2017 © 2017 DigitalGlobe (Source: U.S. Department of State, NextView License).

In 2014, except for the northern portico, the entirety of the complex was destroyed. The mosque at the centre of the complex appears to have been demolished by explosives, which caused the building to cave in, and all that remains is a large crater (see Figure 38).

Al-Khusrawiyya complex was of exceptional historical importance as the first Ottoman-style complex in Aleppo, which had brought a completely new architectural and urban style to the city. It was considered one of the early works of Mimar Sinan that combined the Ottoman style with local building techniques and materials. The architectural and decorative elements of the mosque, the magnificent portal, the ceramic tiles above the windows, the mihrab, and the minbar in the prayer hall were all valuable examples of this combination. Taking these points into consideration, the overall historical loss is categorized as critical.

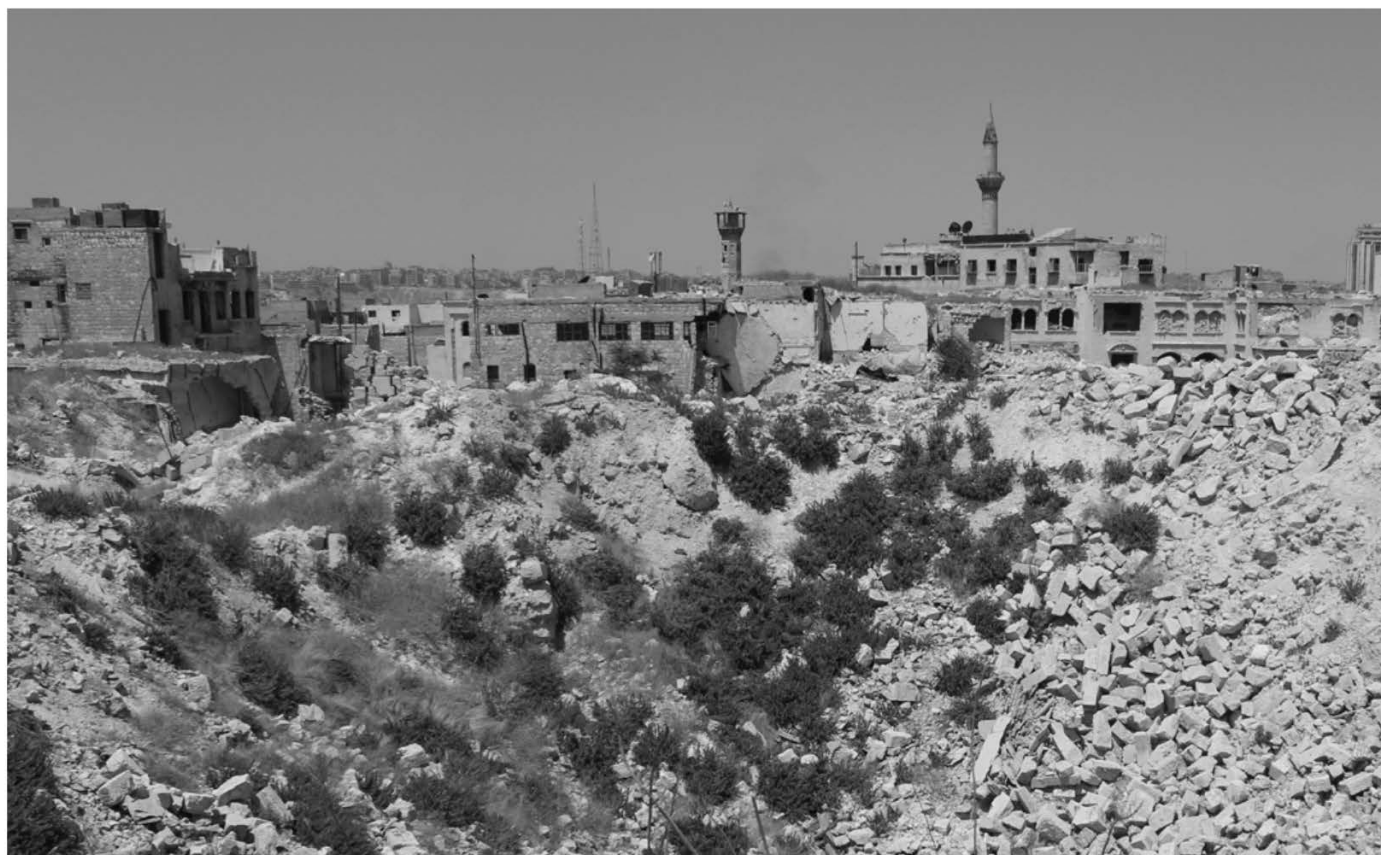
The site of al-Khusrawiyya Complex. Picture date: 16 January 2017 © UNESCO/C. Menegazzi.

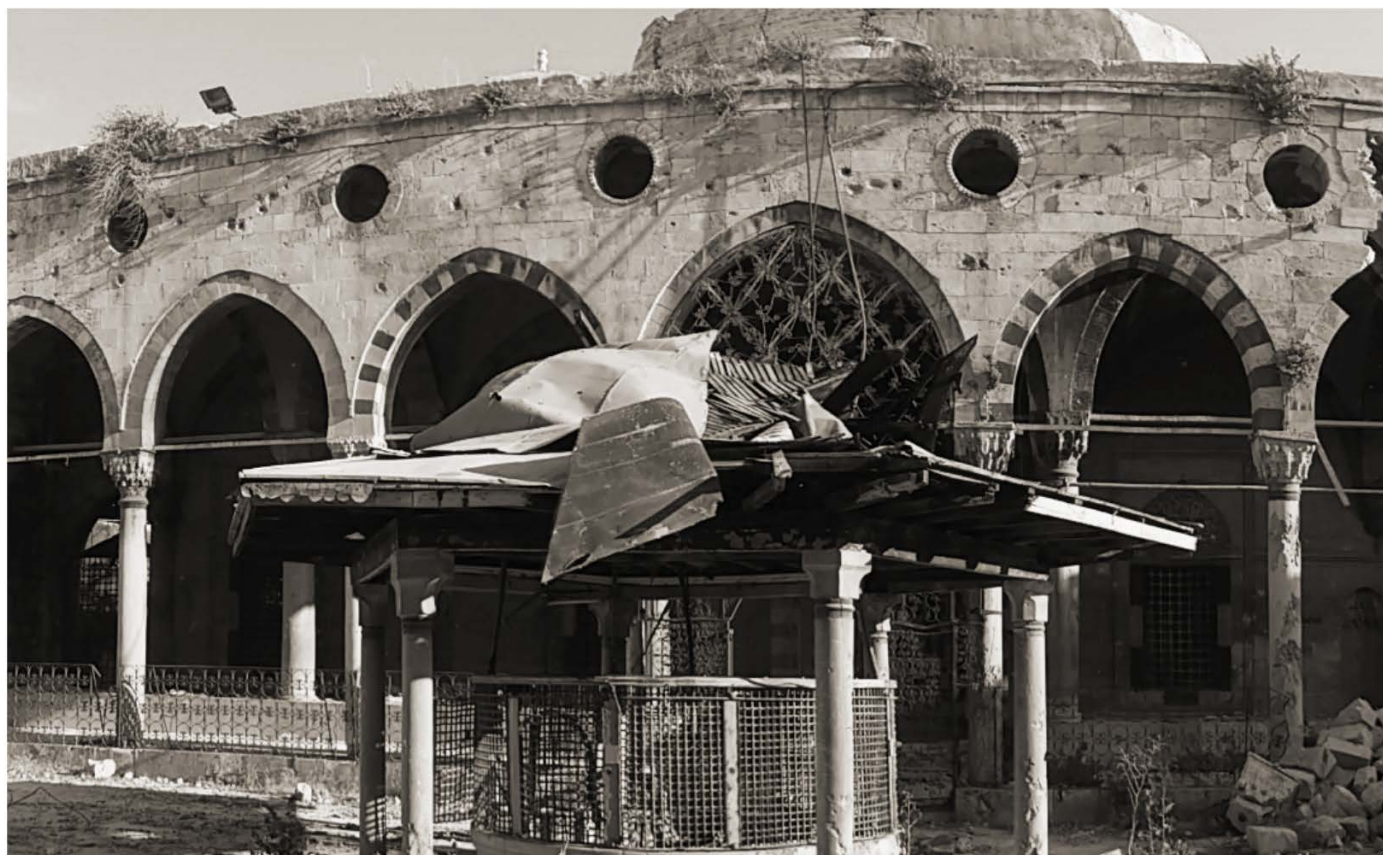
Al-Adiliyya Mosque, the outer portico. Picture date: 16 January 2017 © UNESCO/G. Khawam.

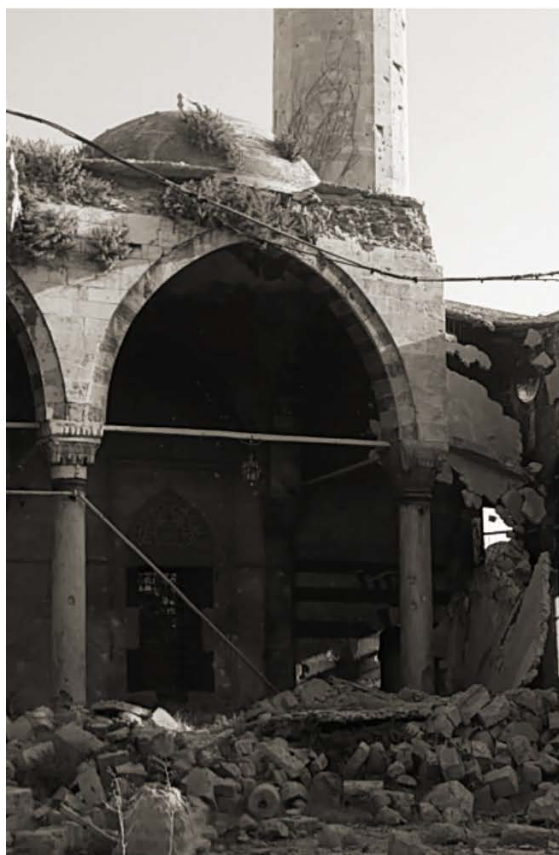
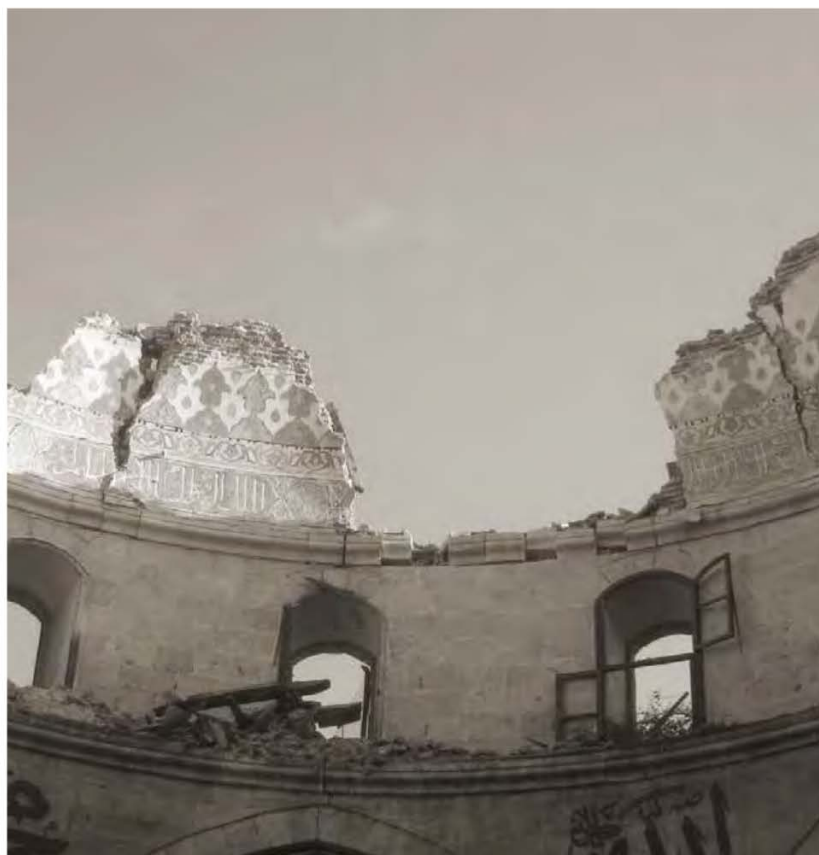
Al-Adiliyya Mosque, the dome of the Prayer Hall. Picture date: 16 January 2017 © UNESCO/C. Menegazzi.

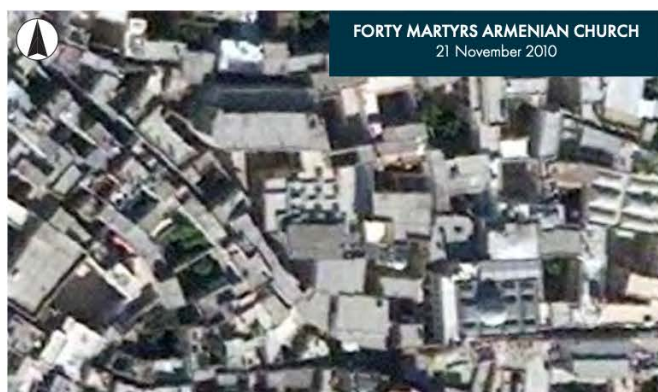
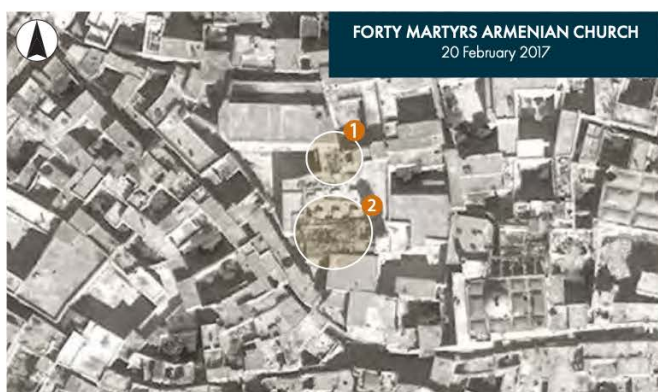
There is debris visible on the roof, particularly on the northern side (see figure 43, Damage Point 1), but the main structure, including the bell tower, appears largely intact. The southern annexed building has sustained severe damage (see Figure 43, Damage Point 2), possibly impacting the main church where they adjoin.

This is the oldest active church in the Armenian diaspora and in the city of Aleppo, and is particularly rich in icons with more than 30 samples. The bell tower is considered a unique example of baroque architecture in Aleppo. The overall historical loss is categorized as moderate because the main structure and the bell tower appear largely intact.

- 1** Debris visible on the roof
- 2** Southern building severely damaged

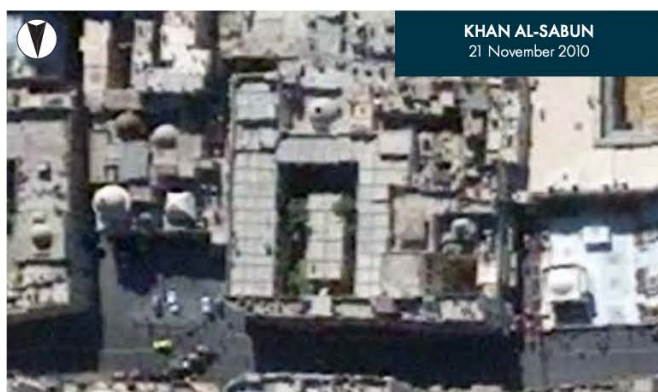
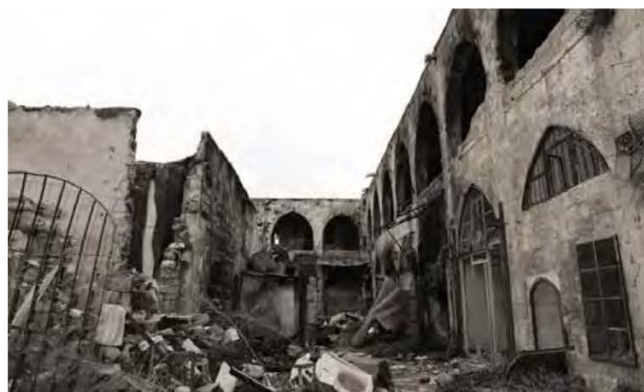
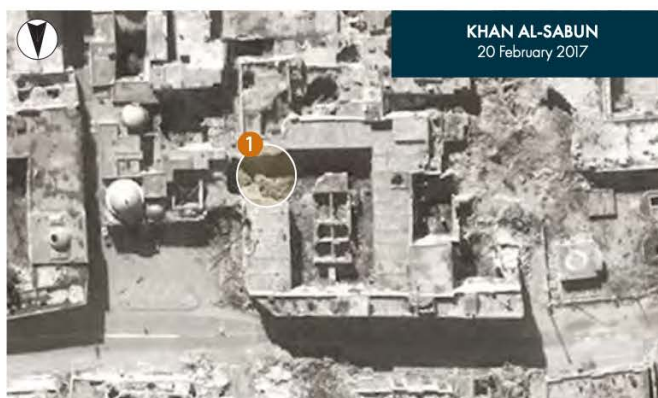
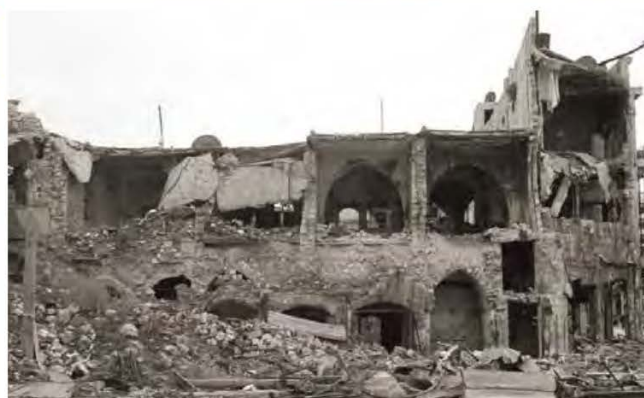
Although assessed as 'destroyed' in 2014, the level and extent of the damage of the khan has been reassessed. The khan itself has sustained severe damage and several sections have been destroyed (see Figure 45, Damage Point 1), but the majority of the building is standing, albeit with holes in the roof and piles of rubble indicating further damage.

Khan al-Sabun was one of the best preserved examples of the Mamluk urban khans in Aleppo, and the first large khan built in the central commercial zone (al-Mdineh). Architecturally, it is highly valuable for its rich decorative details and Mamluk blazons in the entrance façade and the northern façade overlooking the courtyard. The overall historical loss is therefore categorized as severe.

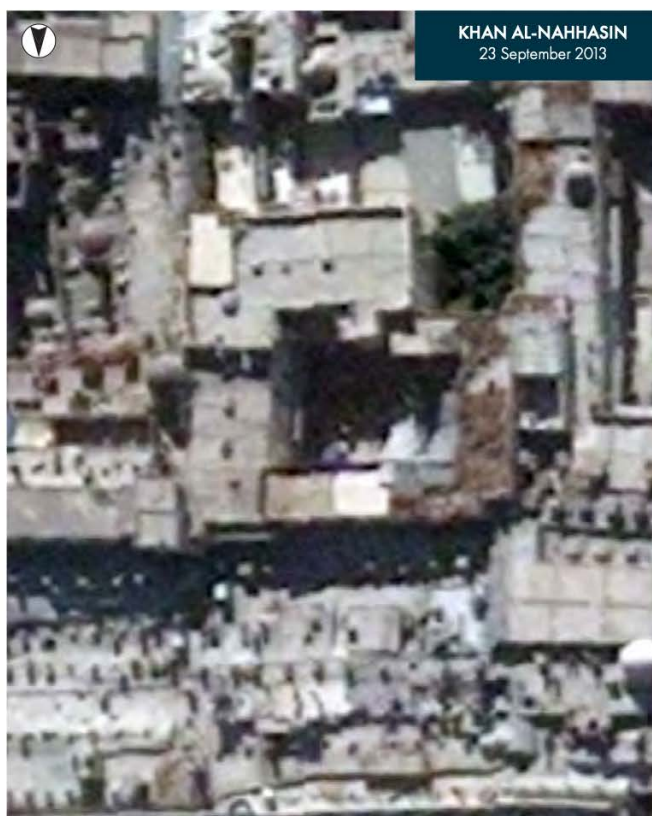
**Figures 46 and 47. Khan al-Nahhasin.** *Left (Before image):* 23 September 2013 © 2013 DigitalGlobe (Source: U.S. Department of State, NextView License). *Right (After image):* 20 February 2017 © 2017 DigitalGlobe (Source: U.S. Department of State, NextView License).

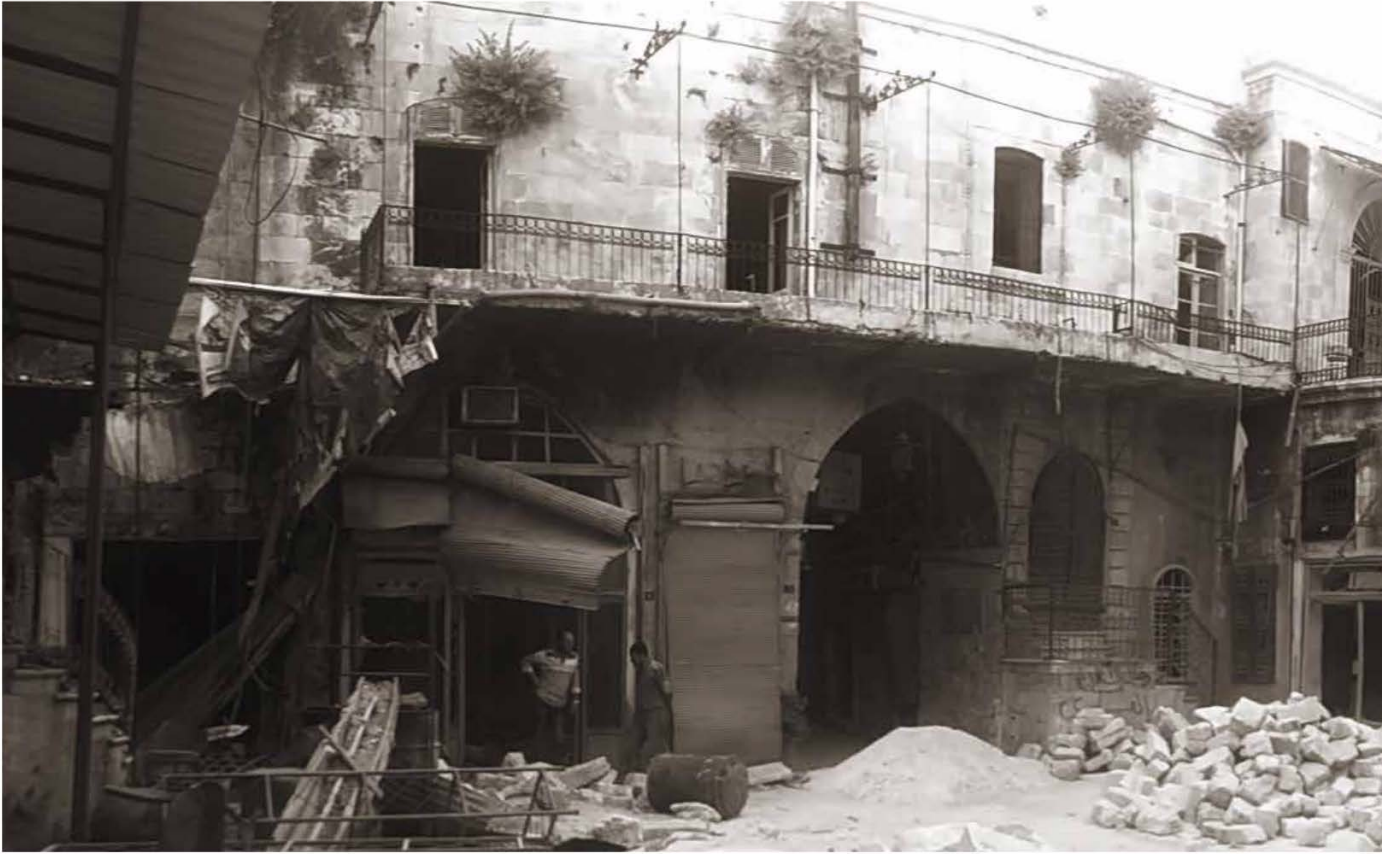
The khan has sustained severe damage as the southwestern corner is completely destroyed (see Figure 47, Damage Point 2). There is rubble in the courtyard, suggesting additional damage to the walls, and part of the northern section of the roof has collapsed (see Figure 47, Damage Point 1). In 2014, the Directorate General of Antiquities and Museums (DGAM) reported the looting of some elements of the high-value private collection of the Poche house.

Courtyard of Khan al-Nahhasin. Picture date: 14 June 2017 © UNESCO/M. Samman.

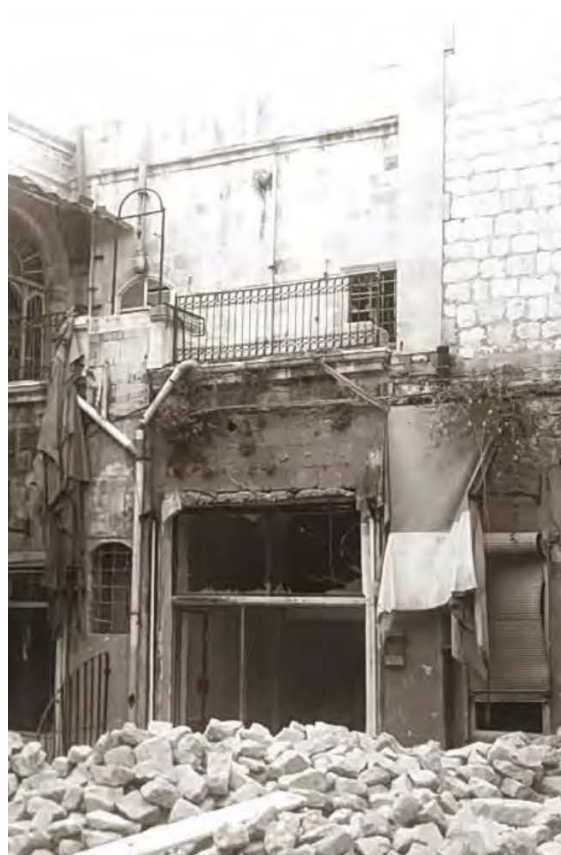
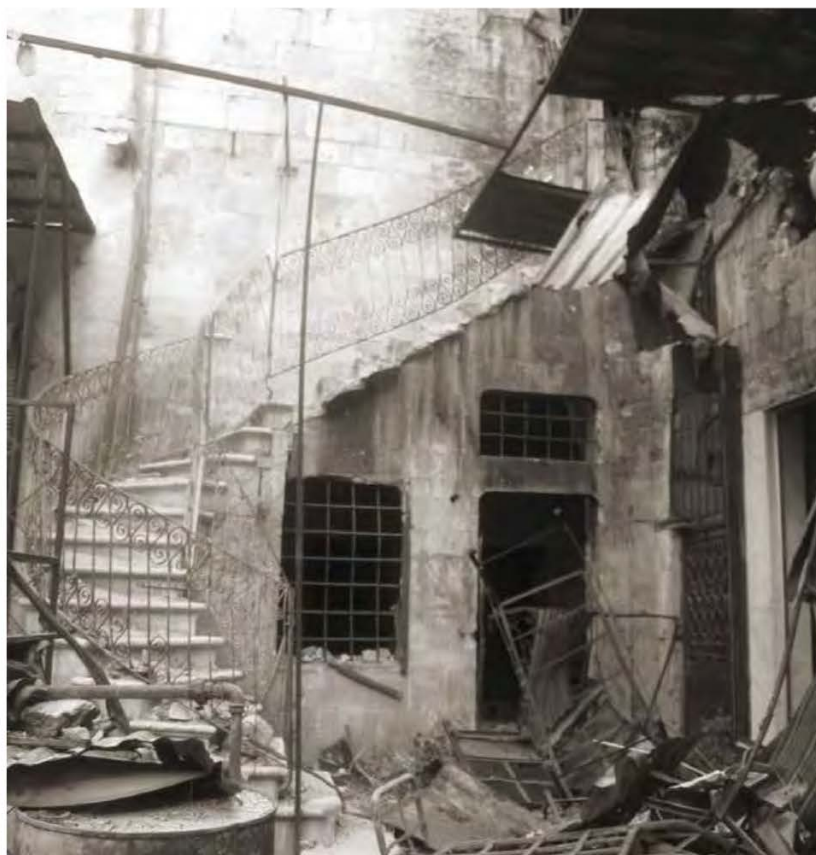
Khan al-Nahhasin. The courtyard's northeastern corner. Picture date: 14 June 2017 © UNESCO/M. Samman.
