# FIVE YEARS OF CONFLICT

The State of Cultural  
Heritage in the  
Ancient City of Aleppo

A comprehensive multi-temporal satellite  
imagery-based damage analysis for the  
Ancient City of Aleppo

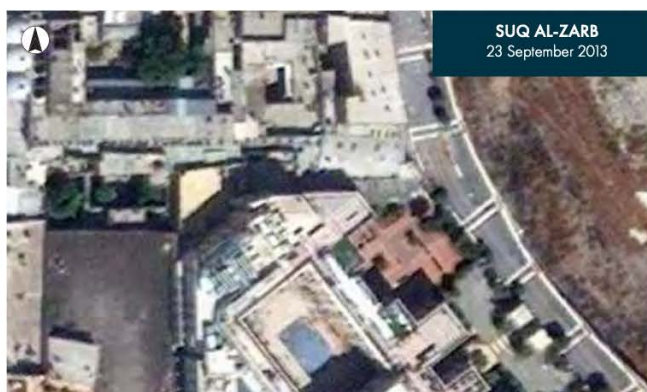
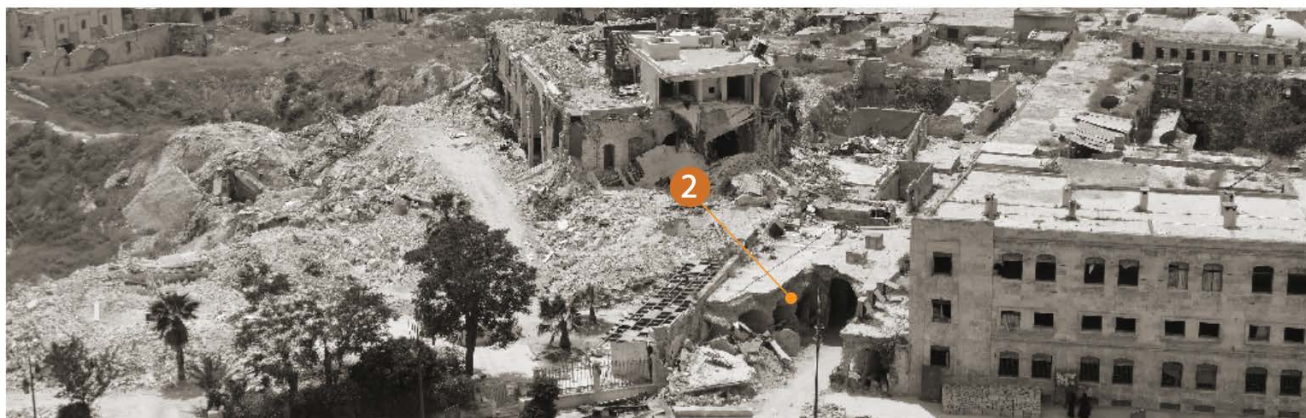
**Figures 48 and 49. Suq al-Zarb. Top left (Before image):** 23 September 2013 © 2013 DigitalGlobe (Source: U.S. Department of State, NextView License). **Top right (After image):** 20 February 2017 © 2017 DigitalGlobe (Source: U.S. Department of State, NextView License). **Ground picture. Bottom:** Suq al-Zarb. Picture date: 28 May 2017 © Art Graphique & Patrimoine.

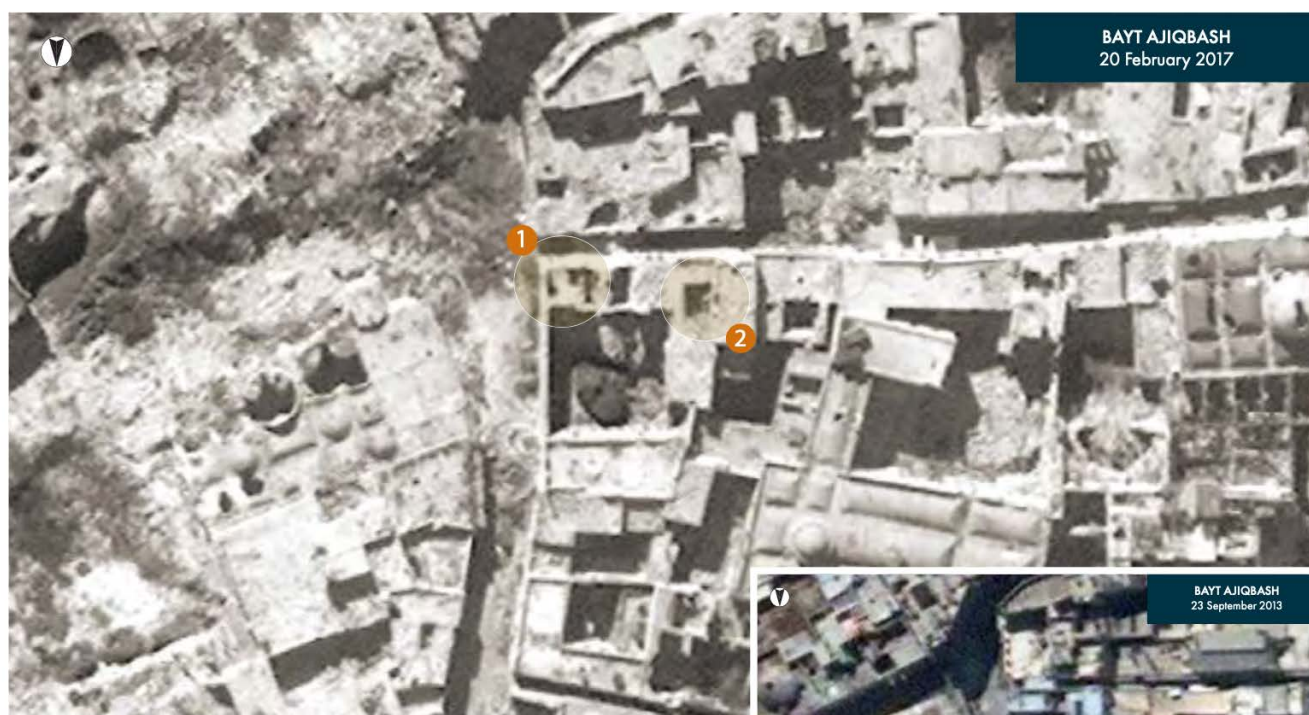
**Figures 50 and 51. Bayt Ajiqbash. Bottom right (Before image):** 23 September 2013 © 2013 DigitalGlobe (Source: U.S. Department of State, NextView License). **Full page (After image):** 20 February 2017 © 2017 DigitalGlobe (Source: U.S. Department of State, NextView License).

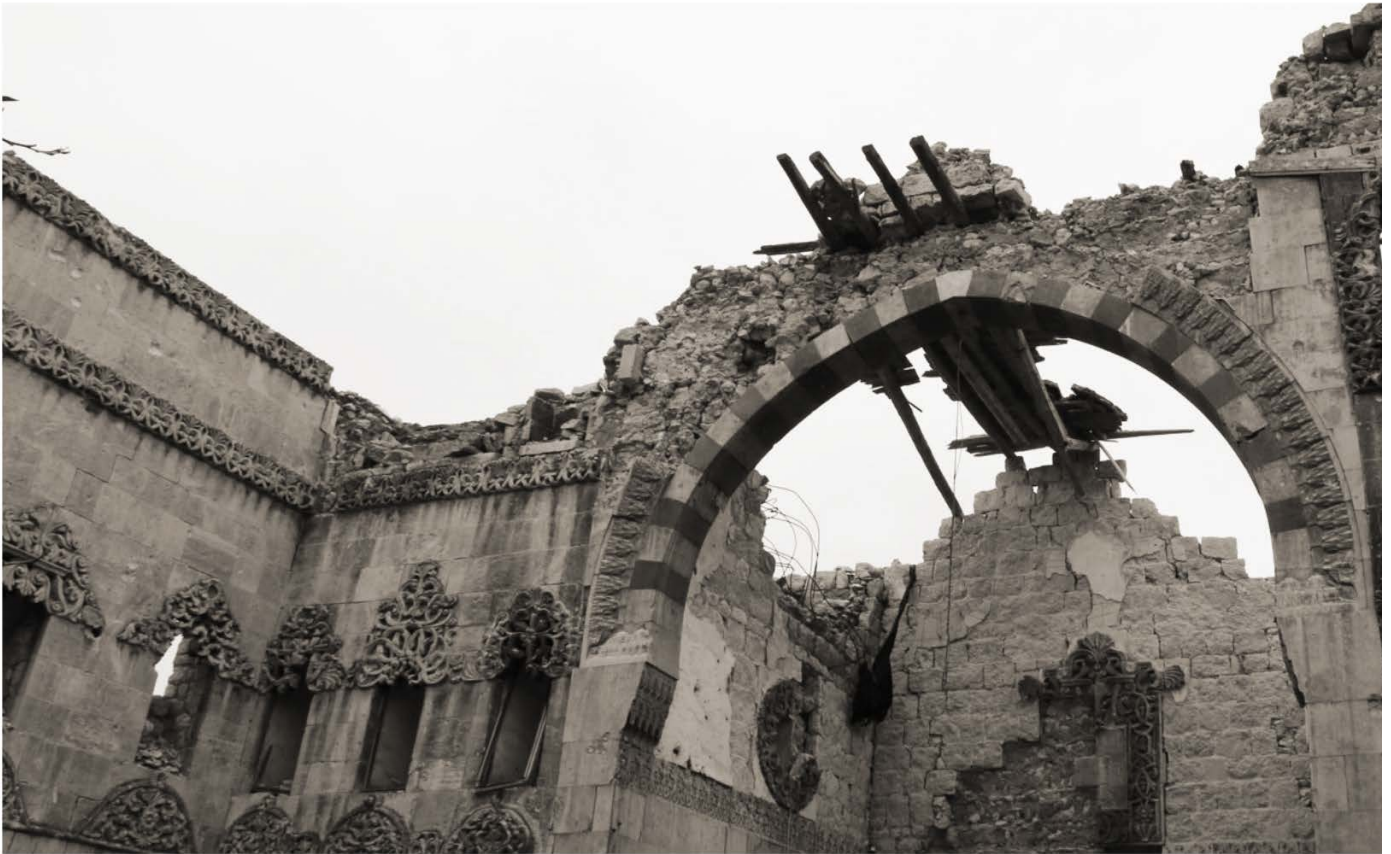
Damaged South Iwan of the Museum of Popular Art and Traditions (Bayt Ajiqbash). Picture date: 16 January 2017 © UNESCO/C. Menegazzi.

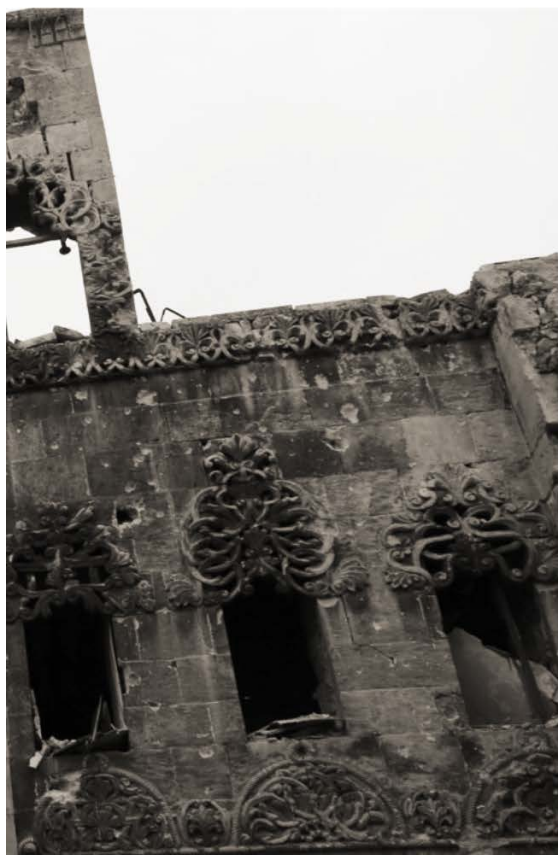
Archive photo of the South Iwan, Museum of Popular Art and Traditions (Bayt Ajiqbash). Picture date: April 2009 © Gerhard Huber.

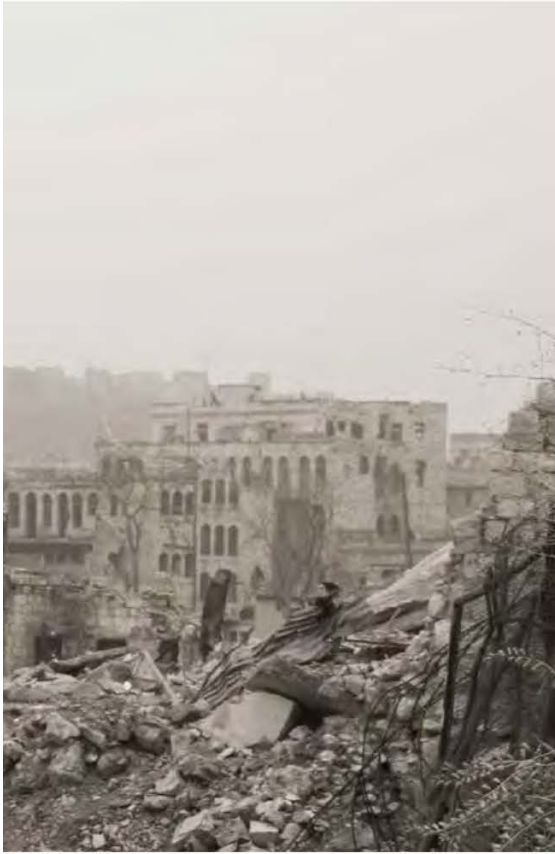
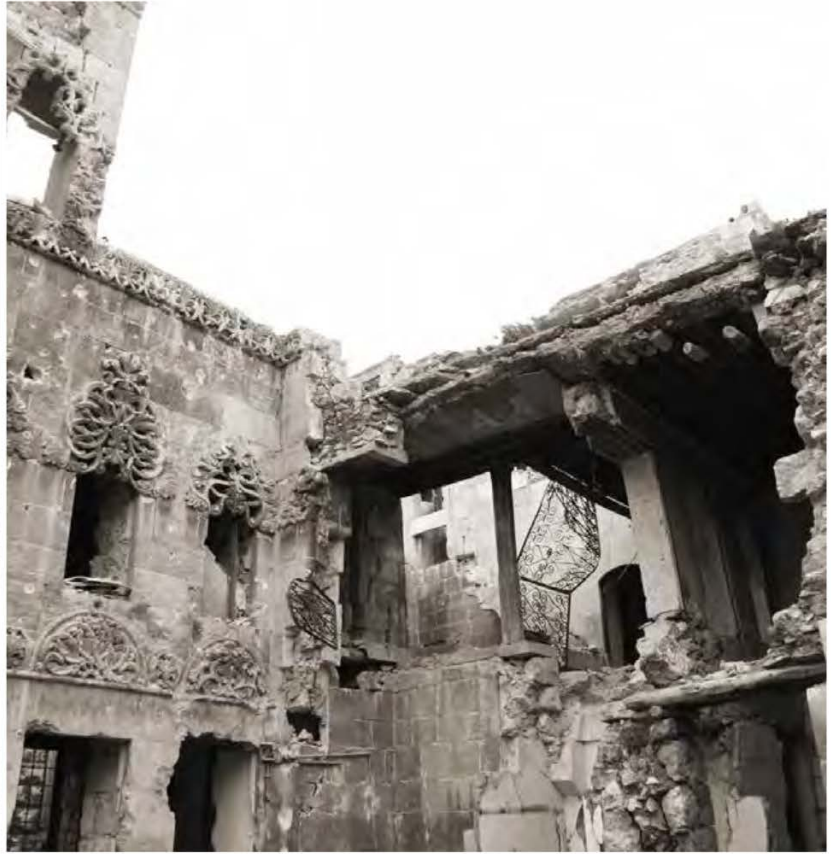
- 1 Roof of building damaged and small section of southeast corner of building collapsed
- 2 Southwest corner of the roof damaged

Museum of Popular Art and Traditions, southwest corner. Picture date: 16 January 2017 © UNESCO/C. Menegazzi.

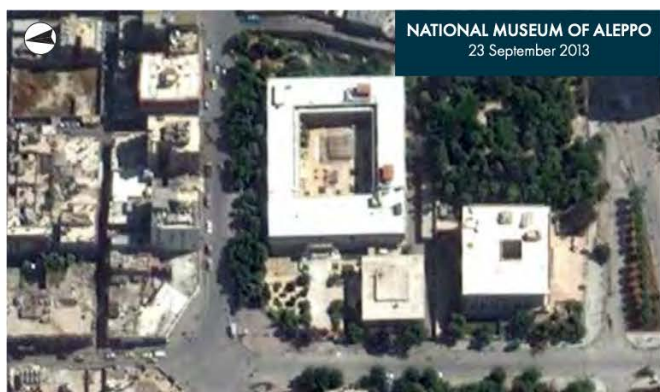
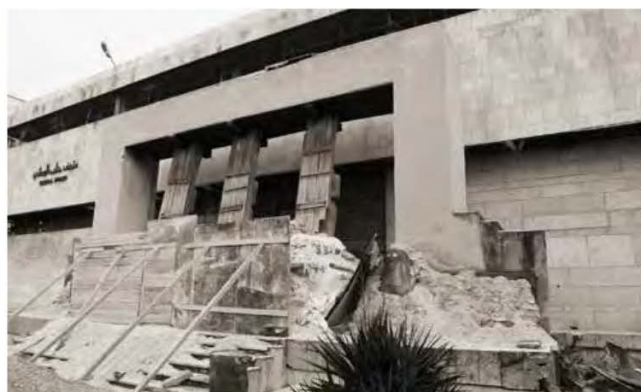
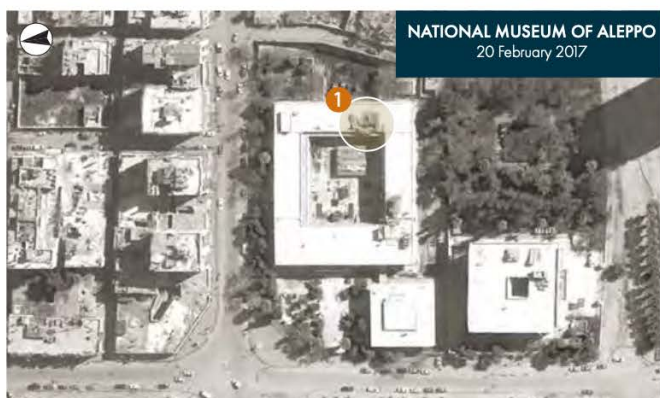
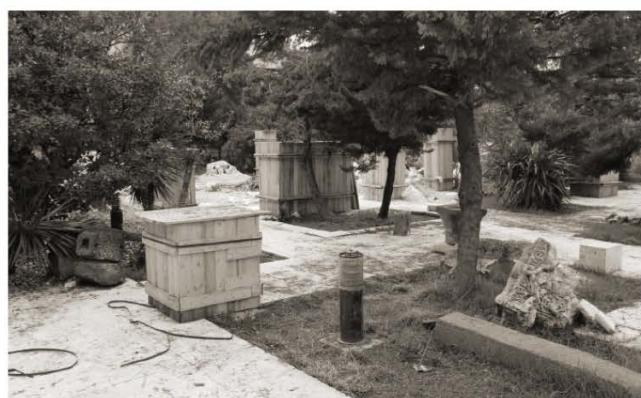
**Figures 52 and 53. National Museum of Aleppo.** *Top left (Before image):* 23 September 2013 © 2013 DigitalGlobe (Source: U.S. Department of State, NextView License). *Bottom left (After image):* 20 February 2017 © 2017 DigitalGlobe (Source: U.S. Department of State, NextView License). *Ground pictures. Top right:* Entombed museum entrance. Picture date: 16 January 2017 © 2017 UNESCO/C. Menegazzi. *Bottom right:* Mitigation measures at the entrance of the National Museum of Aleppo. Picture date: 16 January 2017 © UNESCO/C. Menegazzi.

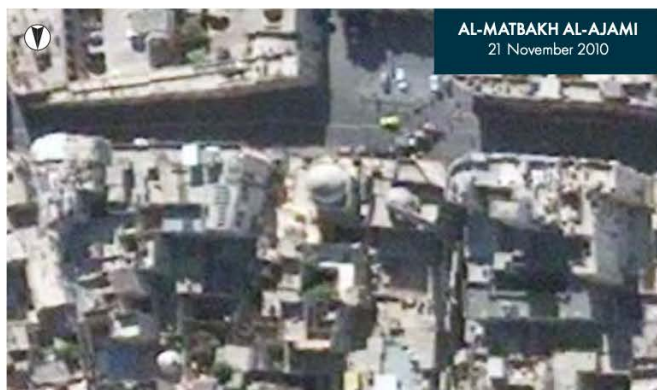
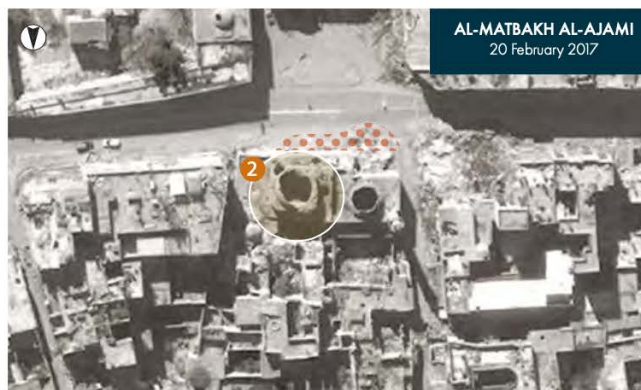
AL-MATBAKH AL-AJAMI  
21 November 2010

Al-Matbakh al-Ajami is the only surviving non-royal palatial residence from medieval Aleppo, if not from all of Syria. Its architectural design and features, the central qa'a with its dome (one of the largest Mamluk domes in Aleppo), the iwans and the northern tripartite façade of the main chamber are all unique examples of the successive styles of medieval Islamic rule. Consequently, the overall historical loss is categorized as severe.

1 Dome damage in 2014

2 Dome completely destroyed in 2017

Visible debris

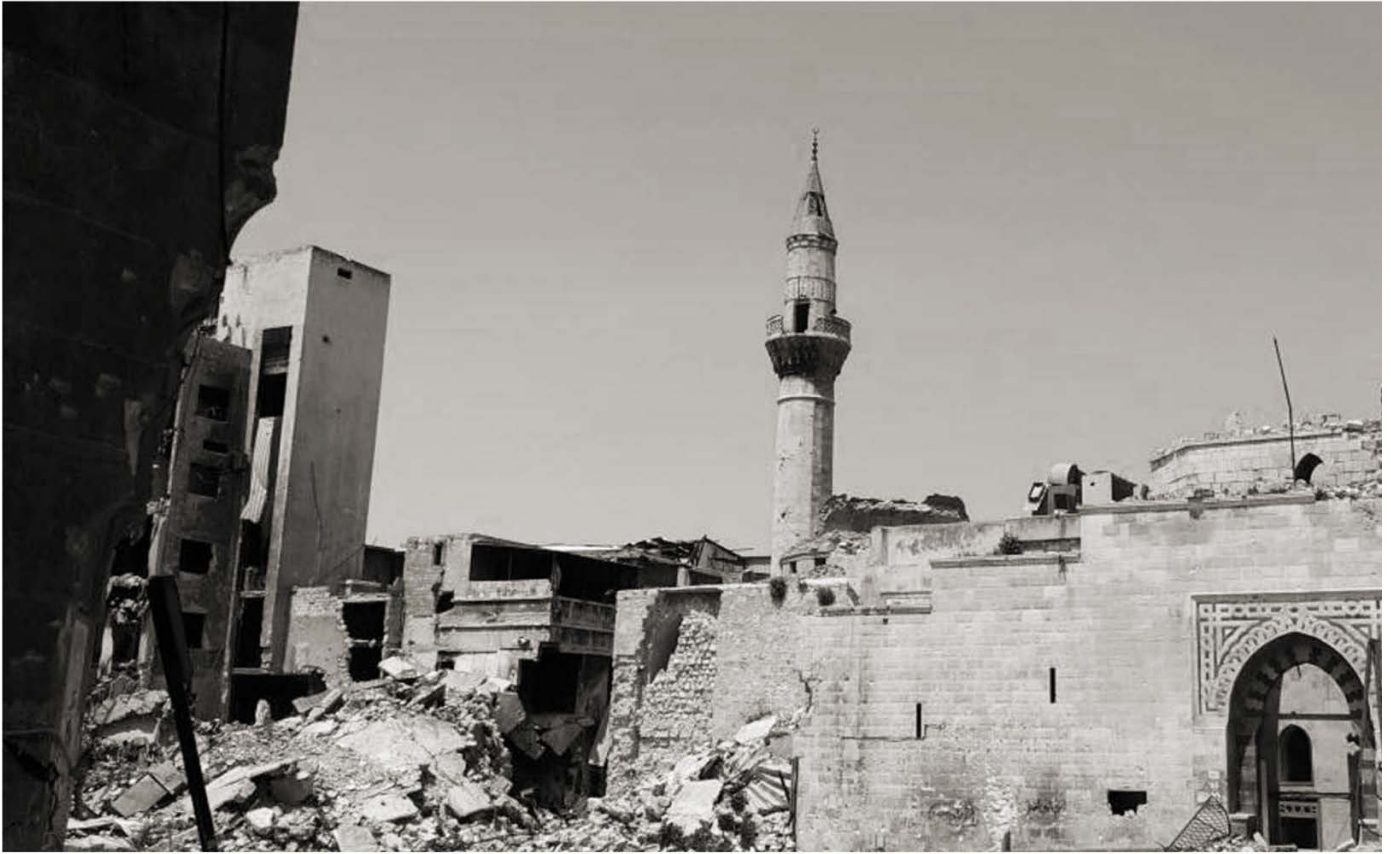
The main façade of al-Matbakh al-Ajami. Picture date: 16 January 2017 © UNESCO/C. Menegazzi.

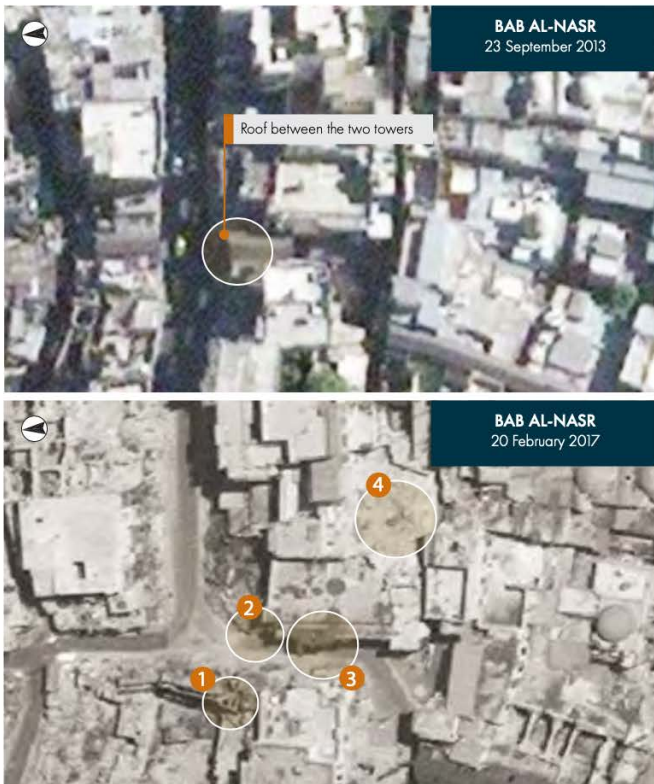
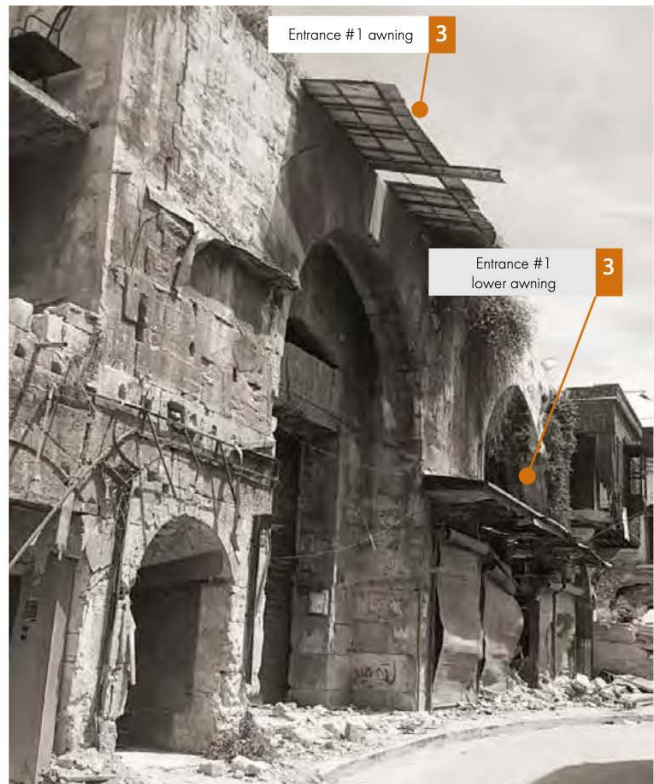
**Figures 57 and 58. Bab al-Nasr.** *Top left (Before image):* 23 September 2013 © 2013 DigitalGlobe (Source: U.S. Department of State, NextView License). *Bottom left (After image):* 20 February 2017 © 2017 DigitalGlobe (Source: U.S. Department of State, NextView License). *Ground picture.* *Right:* The eastern tower of Bab al-Nasr. Picture date: 14 June 2017 © UNESCO/M. Samman.

- 1 Buildings to the north of the western tower collapsed
- 2 Buildings to the north of the eastern tower destroyed
- 3 Entrance #1 and #2 awning (see gap between metal sheets visible on imagery as well)
- 4 Buildings next to the southeastern corner of the eastern tower destroyed and the tower damaged

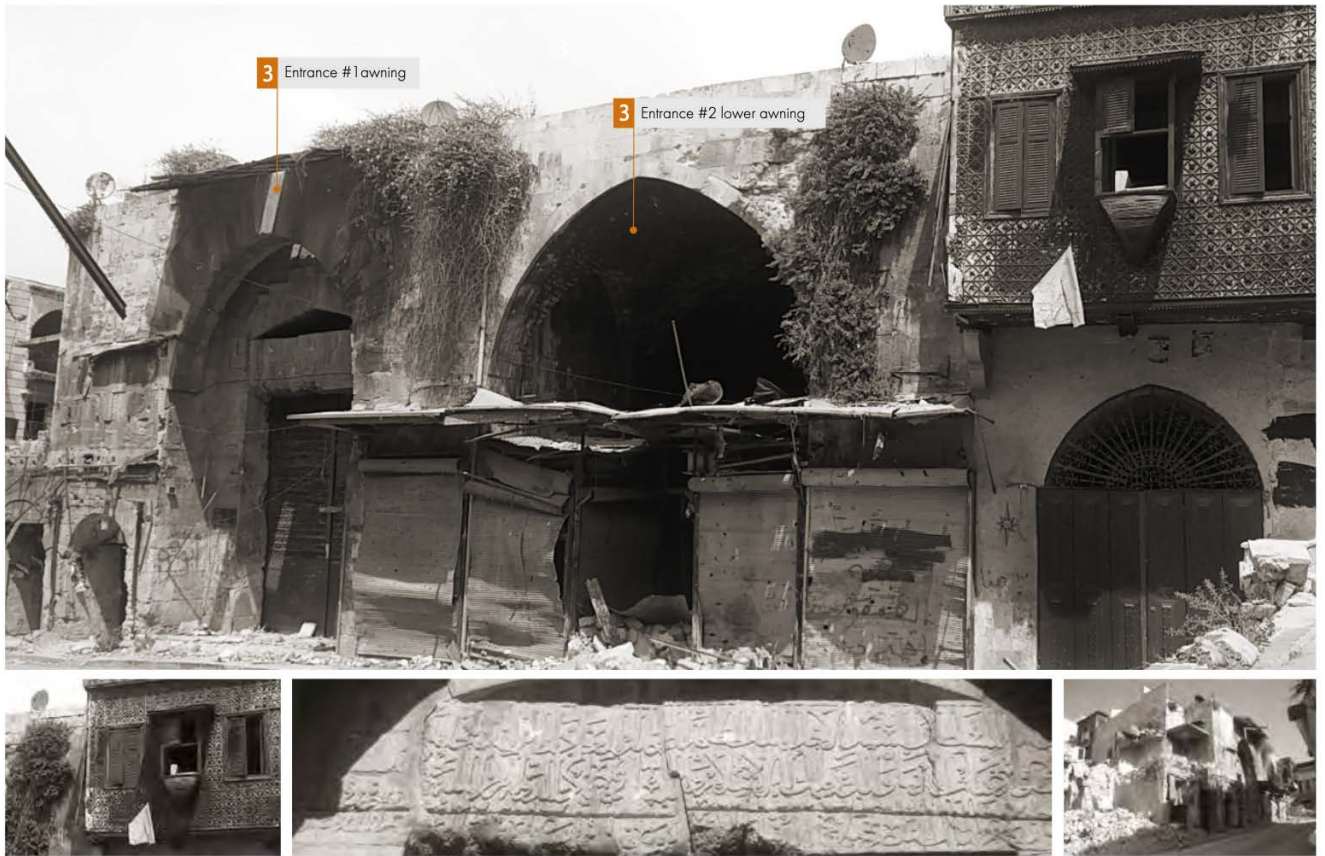
Bab al-Nasr. Perspectives from the eastern tower. Picture date: 14 June 2017 © UNESCO/M. Samman.

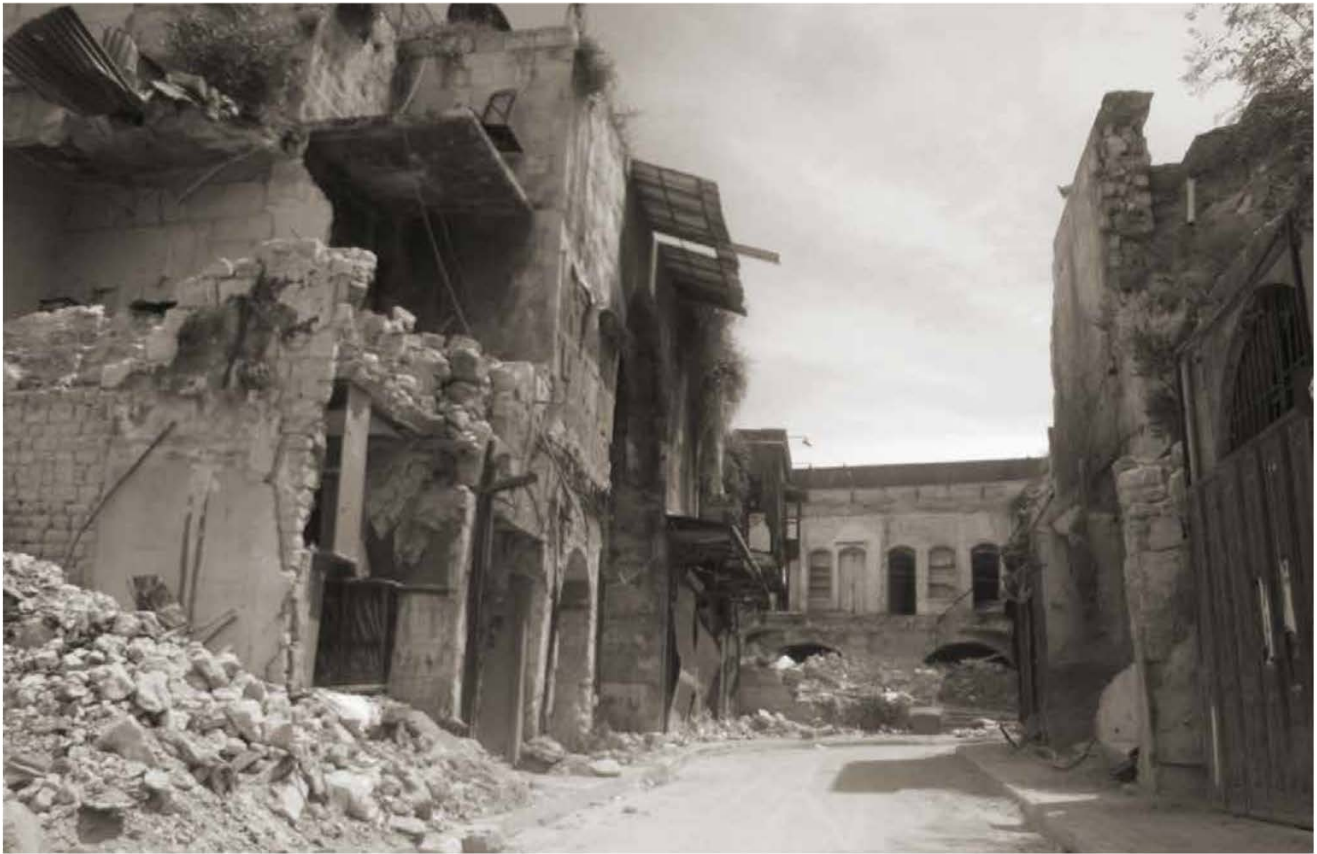
Bab al-Nasr. Gateway looking south. Picture date: 14 June 2017 © UNESCO/M. Samman.

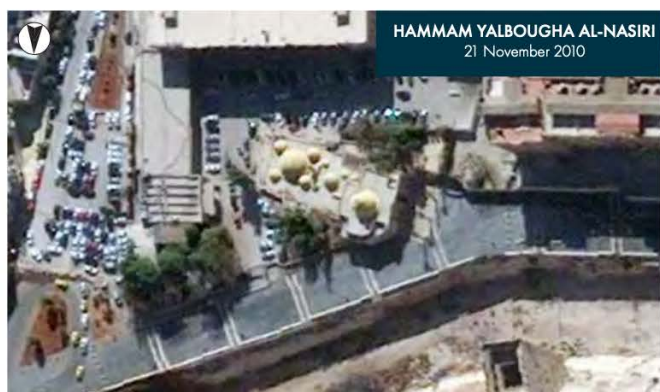
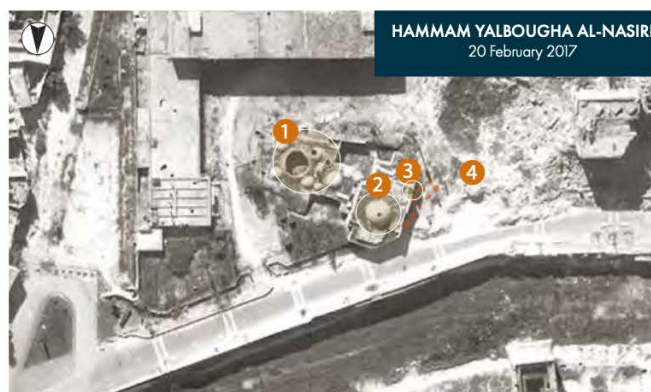
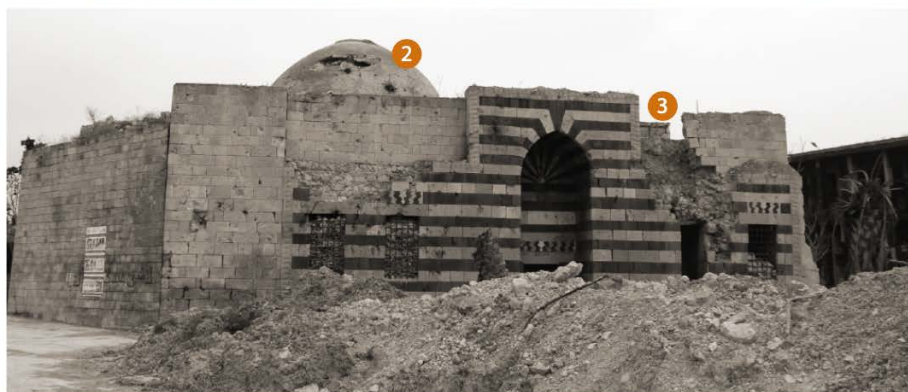
**Figures 59 and 60. Hammam Yalbougha al-Nasiri.** *Top left (Before image):* 21 November 2010 © 2010 DigitalGlobe (Source: U.S. Department of State, NextView License). *Top right (After image):* 20 February 2017 © 2017 DigitalGlobe (Source: U.S. Department of State, NextView License). *Ground pictures. Bottom left:* The main façade of Hammam Yalbougha. Picture date: 16 January 2017 © UNESCO/C. Menegazzi. *Bottom right:* The northern façade of Hammam Yalbougha. Picture date: 16 January 2017 © UNESCO/C. Menegazzi.

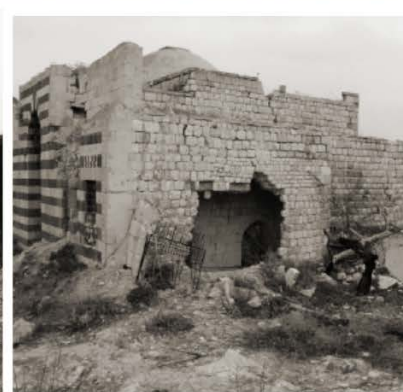
The hammam has suffered severe damage. Several of the domes have collapsed (see Figure 60) or have holes, and there is rubble surrounding it that suggests further damage to the east façade.

1 Damaged and collapsed domes

2 Damaged dome

3 Damage to the façade

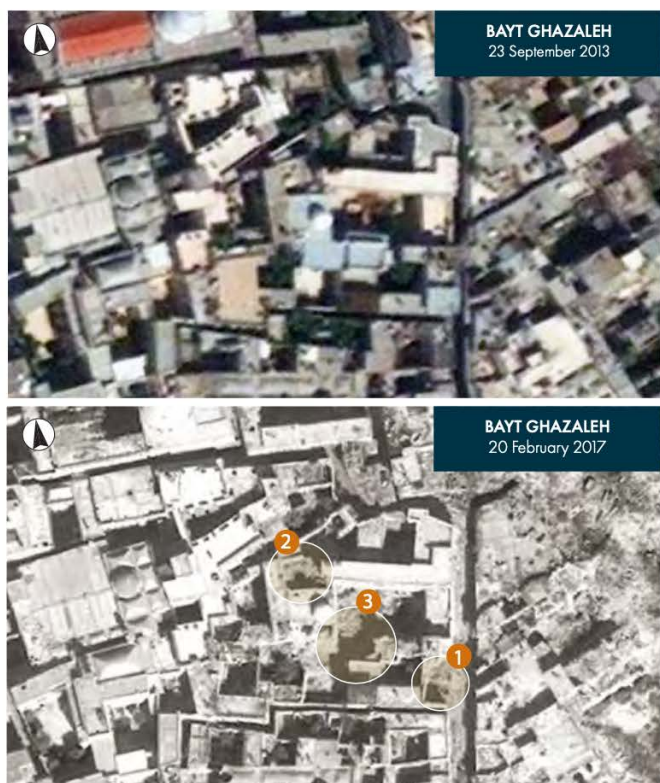
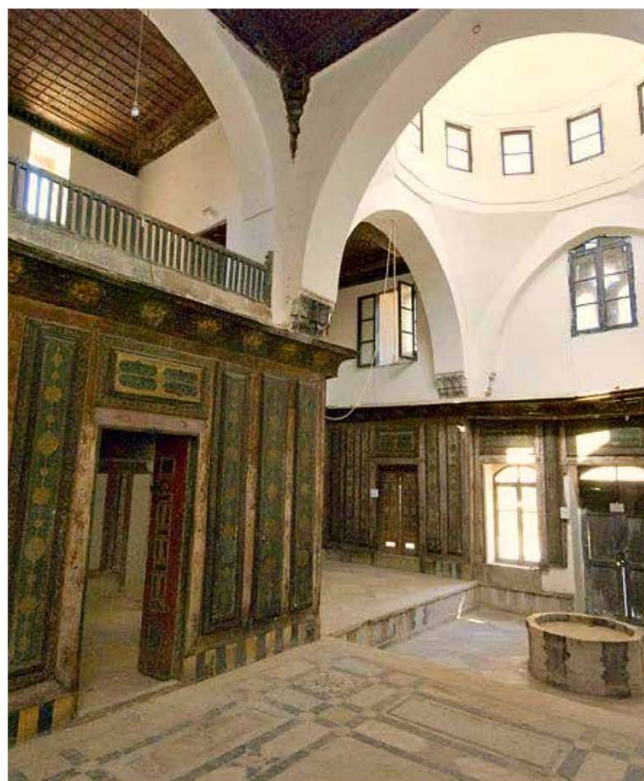
Bayt Ghazaleh has sustained severe damage. The southern iwan (see Figure 62, Damage Point 3) seems mostly destroyed, as is most of the southern part of the building around the courtyard. The hammam and changing rooms in the northwest corner (see Figure 62, Damage Point 2) are heavily damaged, although the dome appears intact. The main courtyard is full of rubble, with additional rubble in the northern courtyard. The eastern side is also heavily damaged, and debris is visible along the length of the outside wall. Much of the rest of the structure shows signs of additional structural damage. The domed reception room, kitchen, service areas and rooms alongside them appear largely intact. In 2014, social media reported that the building's decorative panels were dismantled and transferred to an unknown location. Along the southeast of the building, a row of boutique shops, part of the original structure, are also almost all destroyed (see Figure 62, Damage Point 1).

**Figures 61 and 62. Bayt Ghazaleh.** *Top left (Before image):* 23 September 2013 © 2013 DigitalGlobe (Source: U.S. Department of State, NextView License). *Bottom left (After image):* 20 February 2017 © 2017 DigitalGlobe (Source: U.S. Department of State, NextView License). *Ground picture.* *Right:* Bayt Ghazaleh, western domed reception hall. Picture date: 2001 © Tonino34.

- 1 Southeast building and boutique shops destroyed
- 2 Hammam and changing rooms in the northwest corner
- 3 Southern iwan destroyed

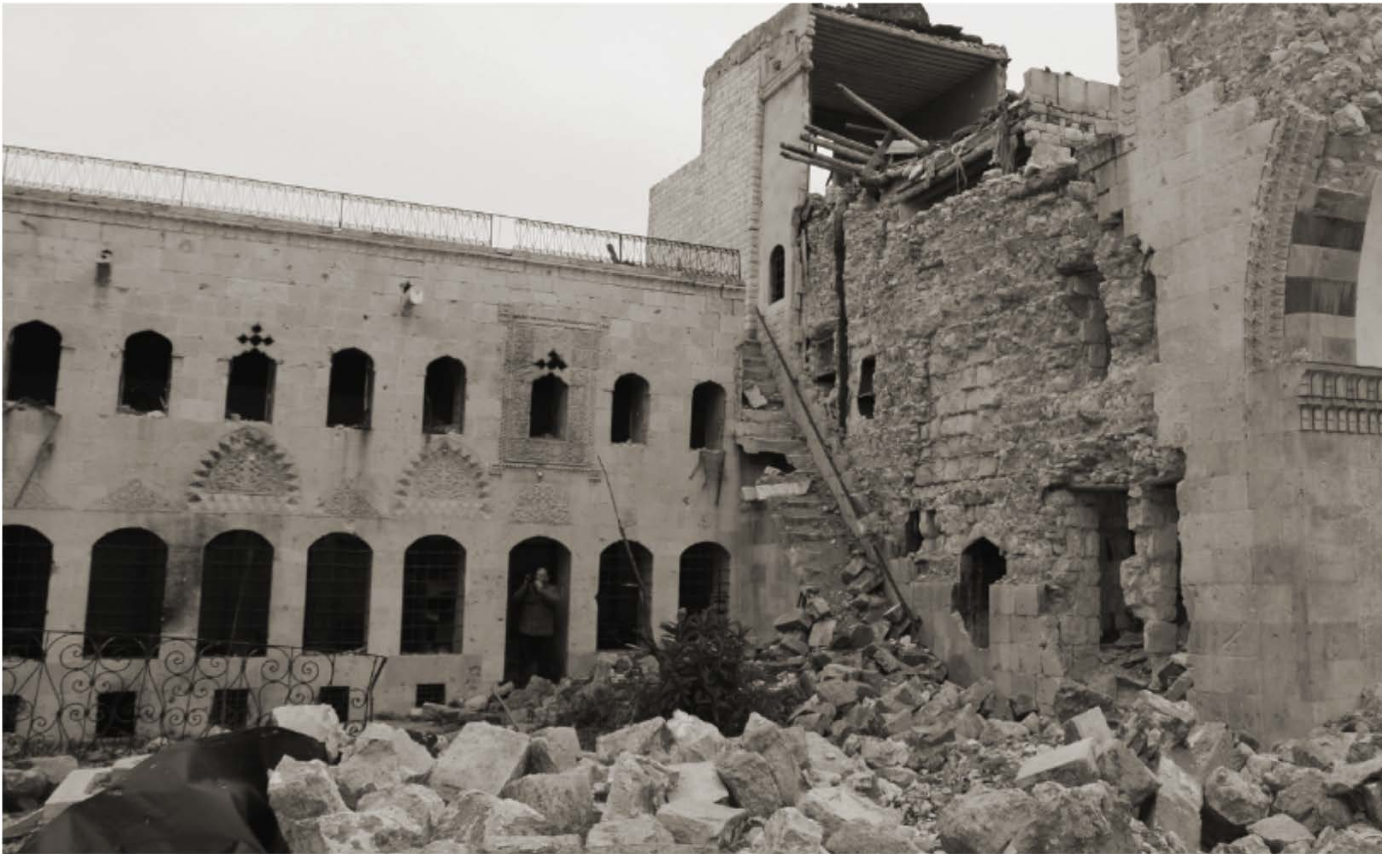
Bayt Ghazaleh, southeastern corner of the residence. Picture date: 16 January 2017 © UNESCO/G.Khawam.

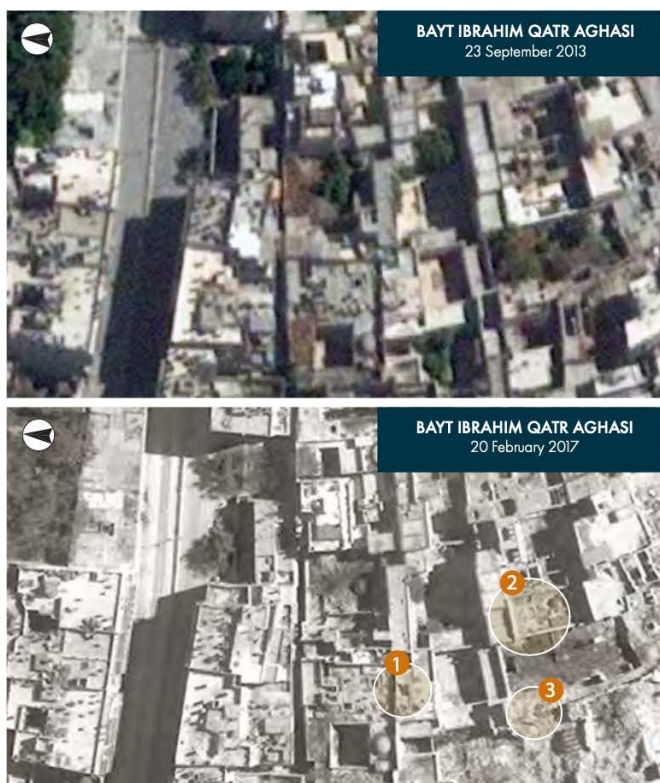
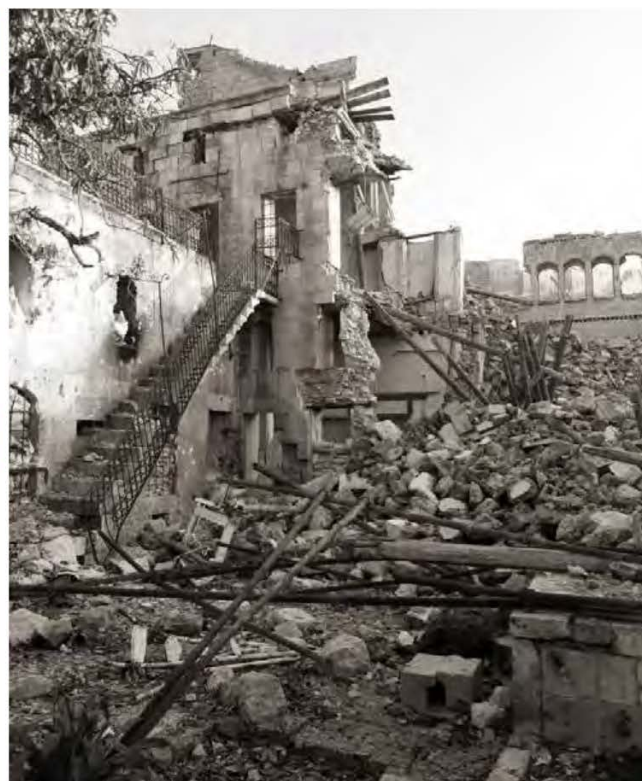
Bayt Ibrahim Qatr Aghasi has sustained severe damage. There has been considerable damage to the northern end of the building with most of the roof destroyed (see Figure 64, Damage Point 1). There are large piles of debris at the base of the south-facing walls in the eastern courtyard (see Figure 64, Damage Point 2) suggesting the walls may have been heavily damaged, though they appear intact in imagery. In addition, a large section of the southernmost part of the building has been severely damaged (see Figure 64, Damage Point 3).

**Figures 63 and 64. Bayt Ibrahim Qatr Aghasi.** *Top left (Before image):* 23 September 2013 © 2013 DigitalGlobe (Source: U.S. Department of State, NextView License). *Bottom left (After image):* 20 February 2017 © 2017 DigitalGlobe (Source: U.S. Department of State, NextView License). *Ground picture. Right:* Bayt Ibrahim Qatr Aghasi. Picture date: December 2016 © DGAM.

- 1 Northern end of the building
- 2 Eastern courtyard (south-facing walls)
- 3 Southernmost part of the building

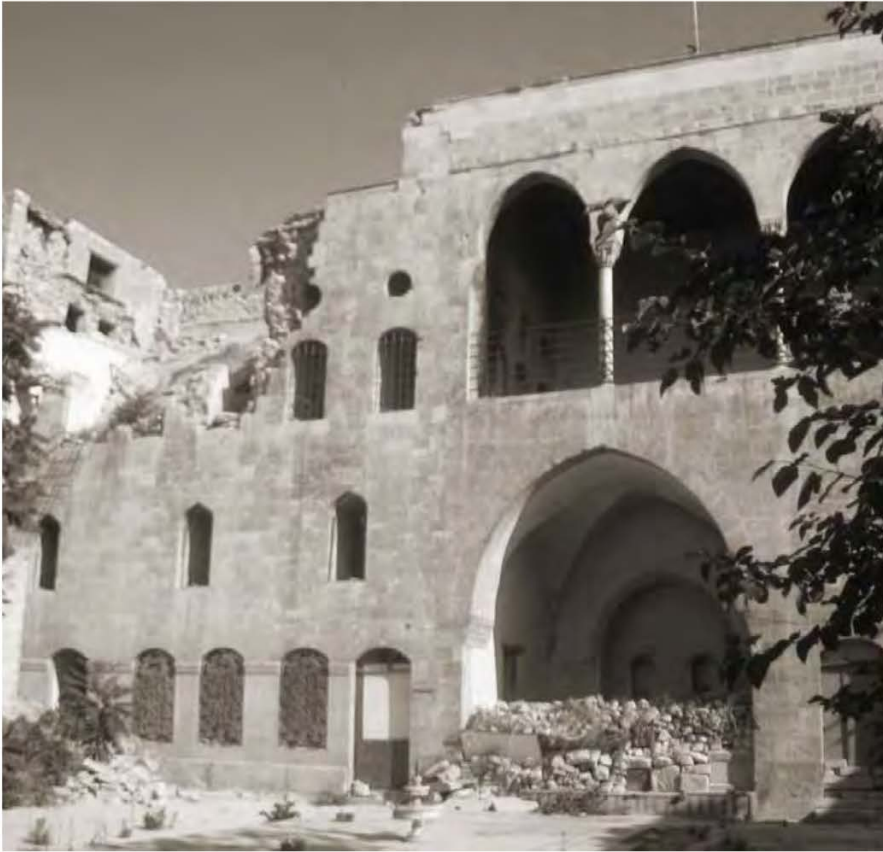
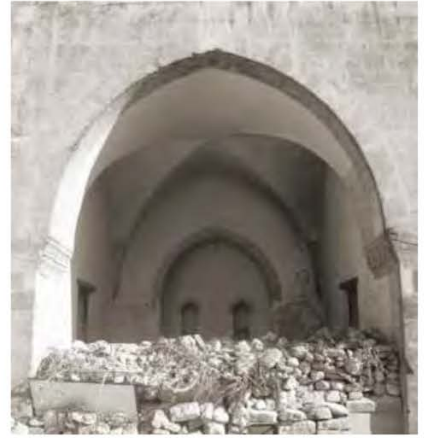
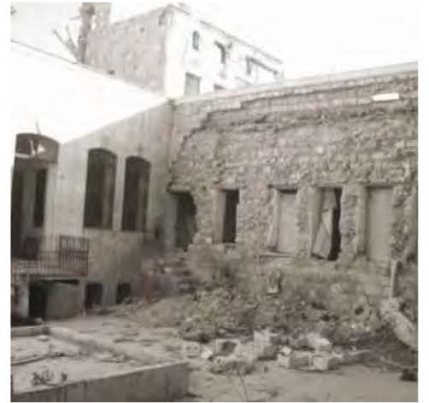
Bayt Ibrahim Qatr Aghasi. **Left:** Bayt Ibrahim Qatr Aghasi. Picture date: 15 June 2017 © UNESCO/M. Samman. **Top right:** Bayt Ibrahim Qatr Aghasi. Picture date: 15 June 2017 © UNESCO/M. Samman. **Bottom right:** Bayt Ibrahim Qatr Aghasi. Picture date: 15 June 2017 © UNESCO/M. Samman.

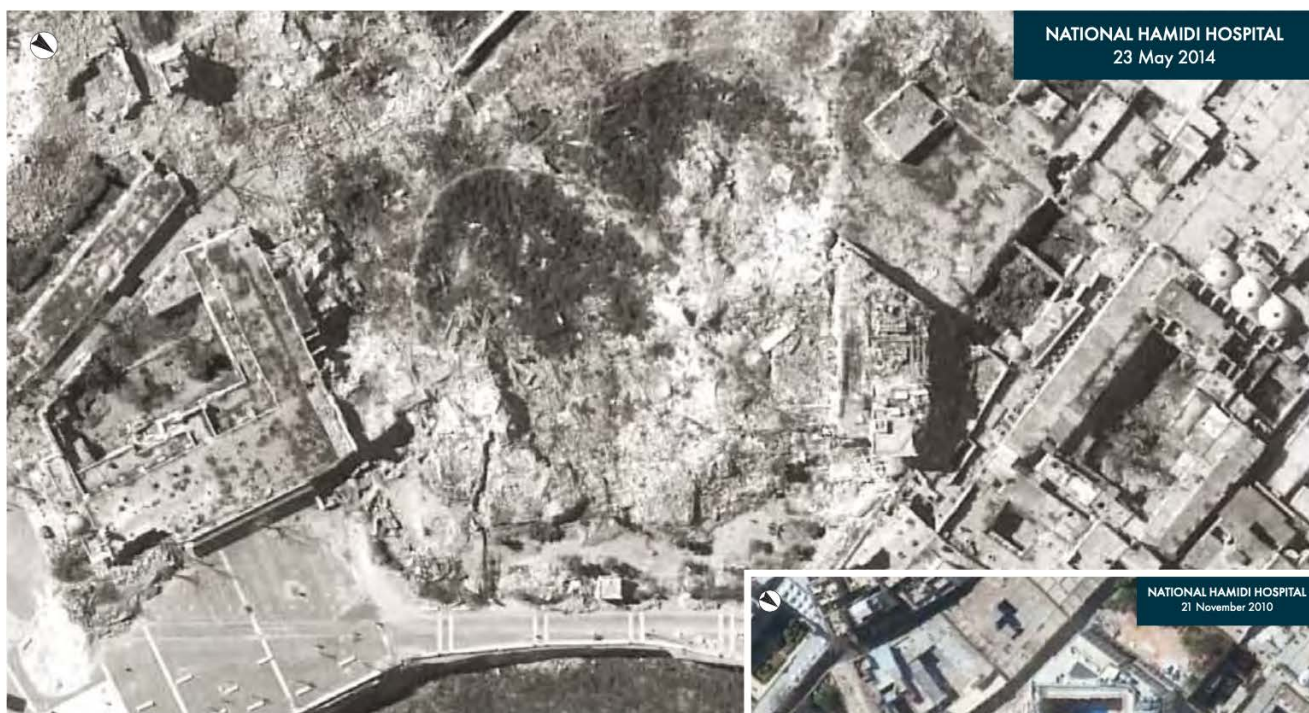
Satellite imagery confirms that the building was completely destroyed, not even the foundations remain (see Figure 66). This was caused by explosives that were placed in a tunnel underneath it in May 2014.

Figures 65 and 66. The National Hamidi Hospital (Carlton Hotel). Bottom right (Before image): 21 November 2010 © 2010 DigitalGlobe (Source: U.S. Department of State, NextView License). Full page (After image): 23 May 2014 © 2014 DigitalGlobe (Source: U.S. Department of State, NextView License).

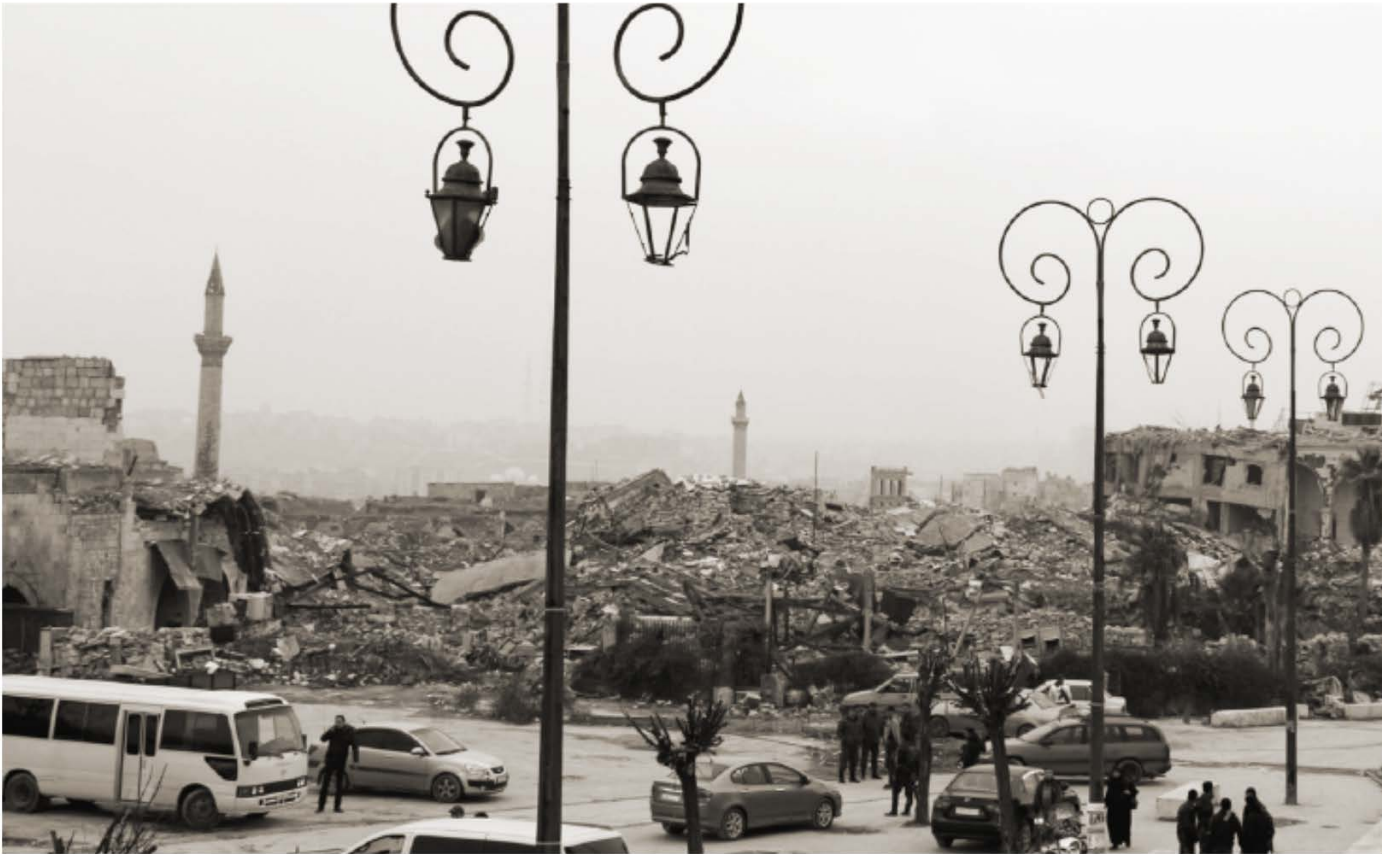
The National Hamid Hospital (Carlton Hotel). Picture date: 16 January 2017 © UNESCO/G. Khawam.

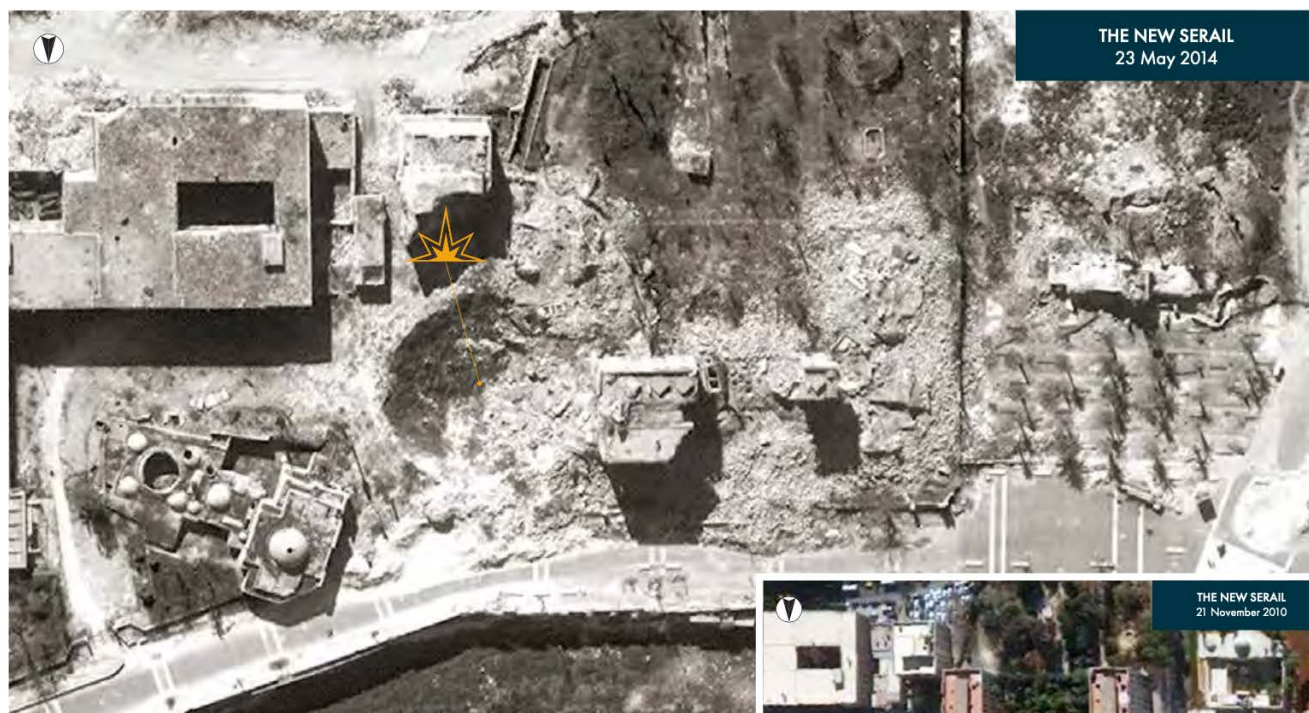
**Figures 67 and 68. The New Serail. Bottom right (Before image):** 21 November 2010 © 2010 DigitalGlobe (Source: U.S. Department of State, NextView License). **Full page (After image):** 23 May 2014 © 2014 DigitalGlobe (Source: U.S. Department of State, NextView License).

Possible impact crater

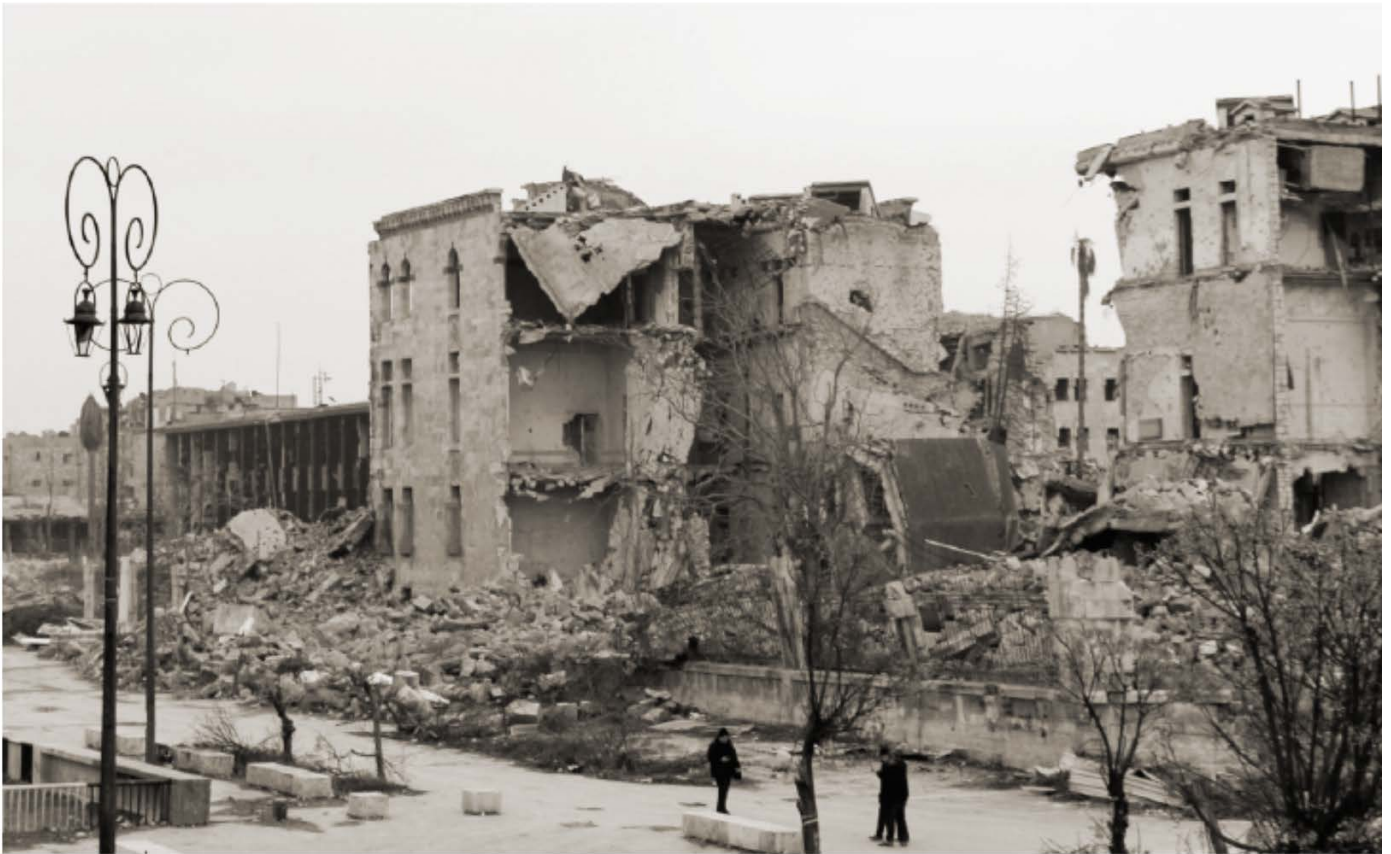
The rubble of the New Serail. Picture date: 16 January 2017 © UNESCO/C. Menegazzi.
