# FIVE YEARS OF CONFLICT

The State of Cultural  
Heritage in the  
Ancient City of Aleppo

A comprehensive multi-temporal satellite  
imagery-based damage analysis for the  
Ancient City of Aleppo

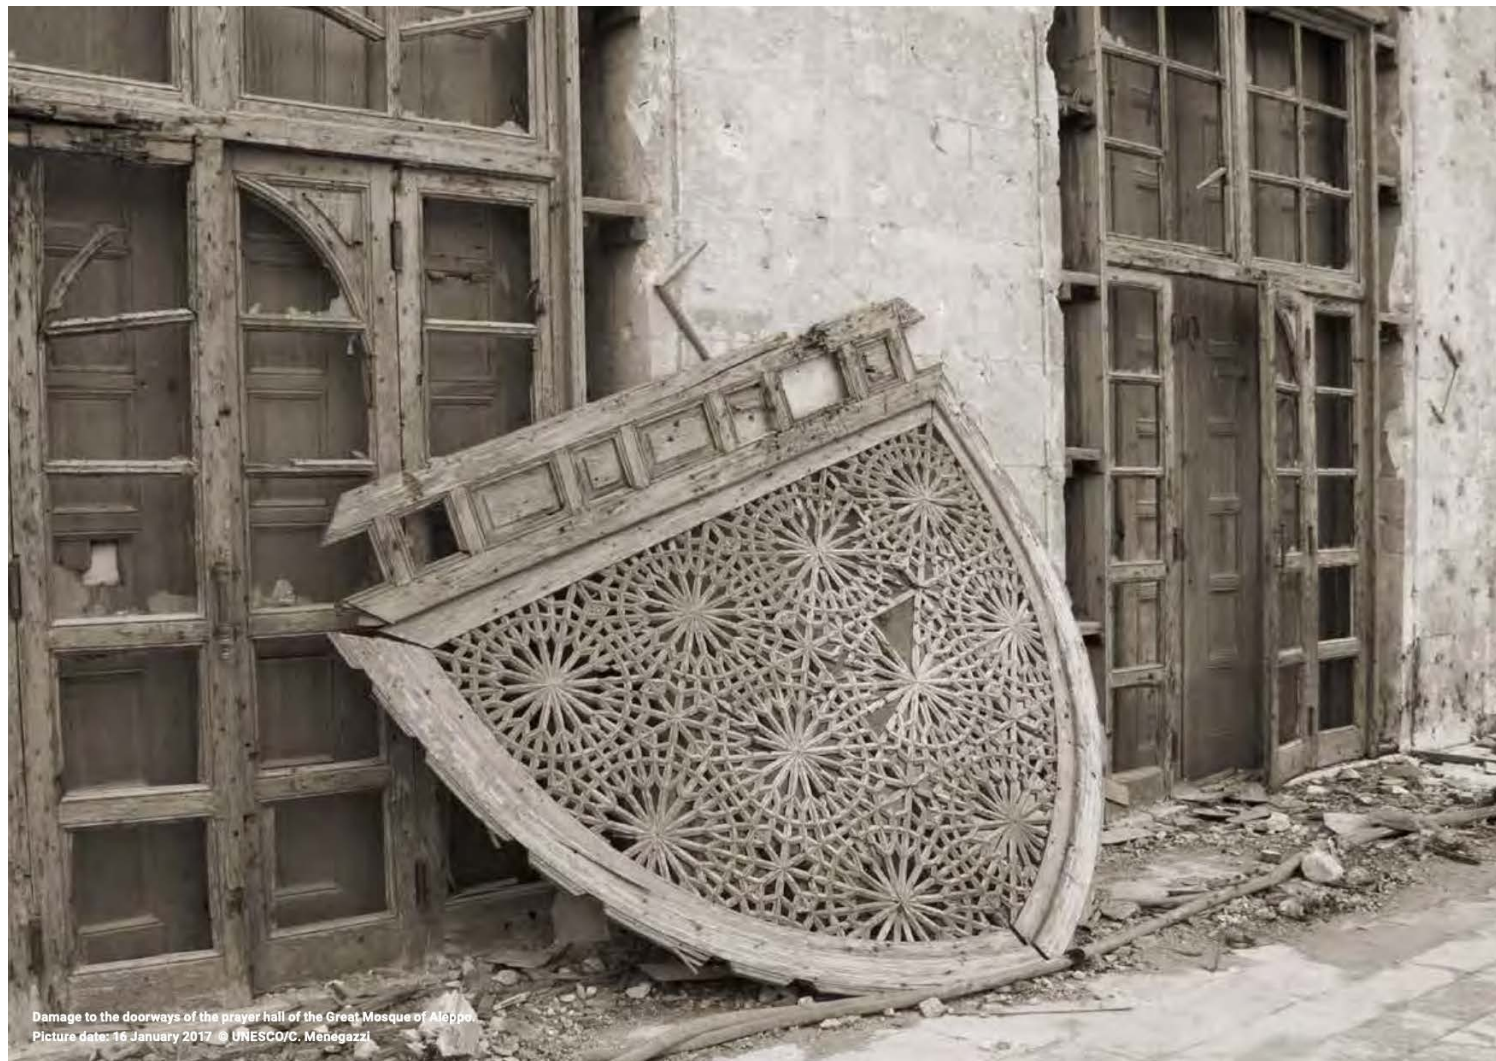
Damage to the doorways of the prayer hall of the Great Mosque of Aleppo.  
Picture date: 16 January 2017 © UNESCO/C. Menegazzi
